GEOMORPHIC ASSESSMENT OF THE BIG WOOD RIVER

**River Mile 79.5 (Glendale Diversion) to River Mile 100.05
(Confluence with Warm Springs Creek)**

Prepared for
Wood River Land Trust

December 2006

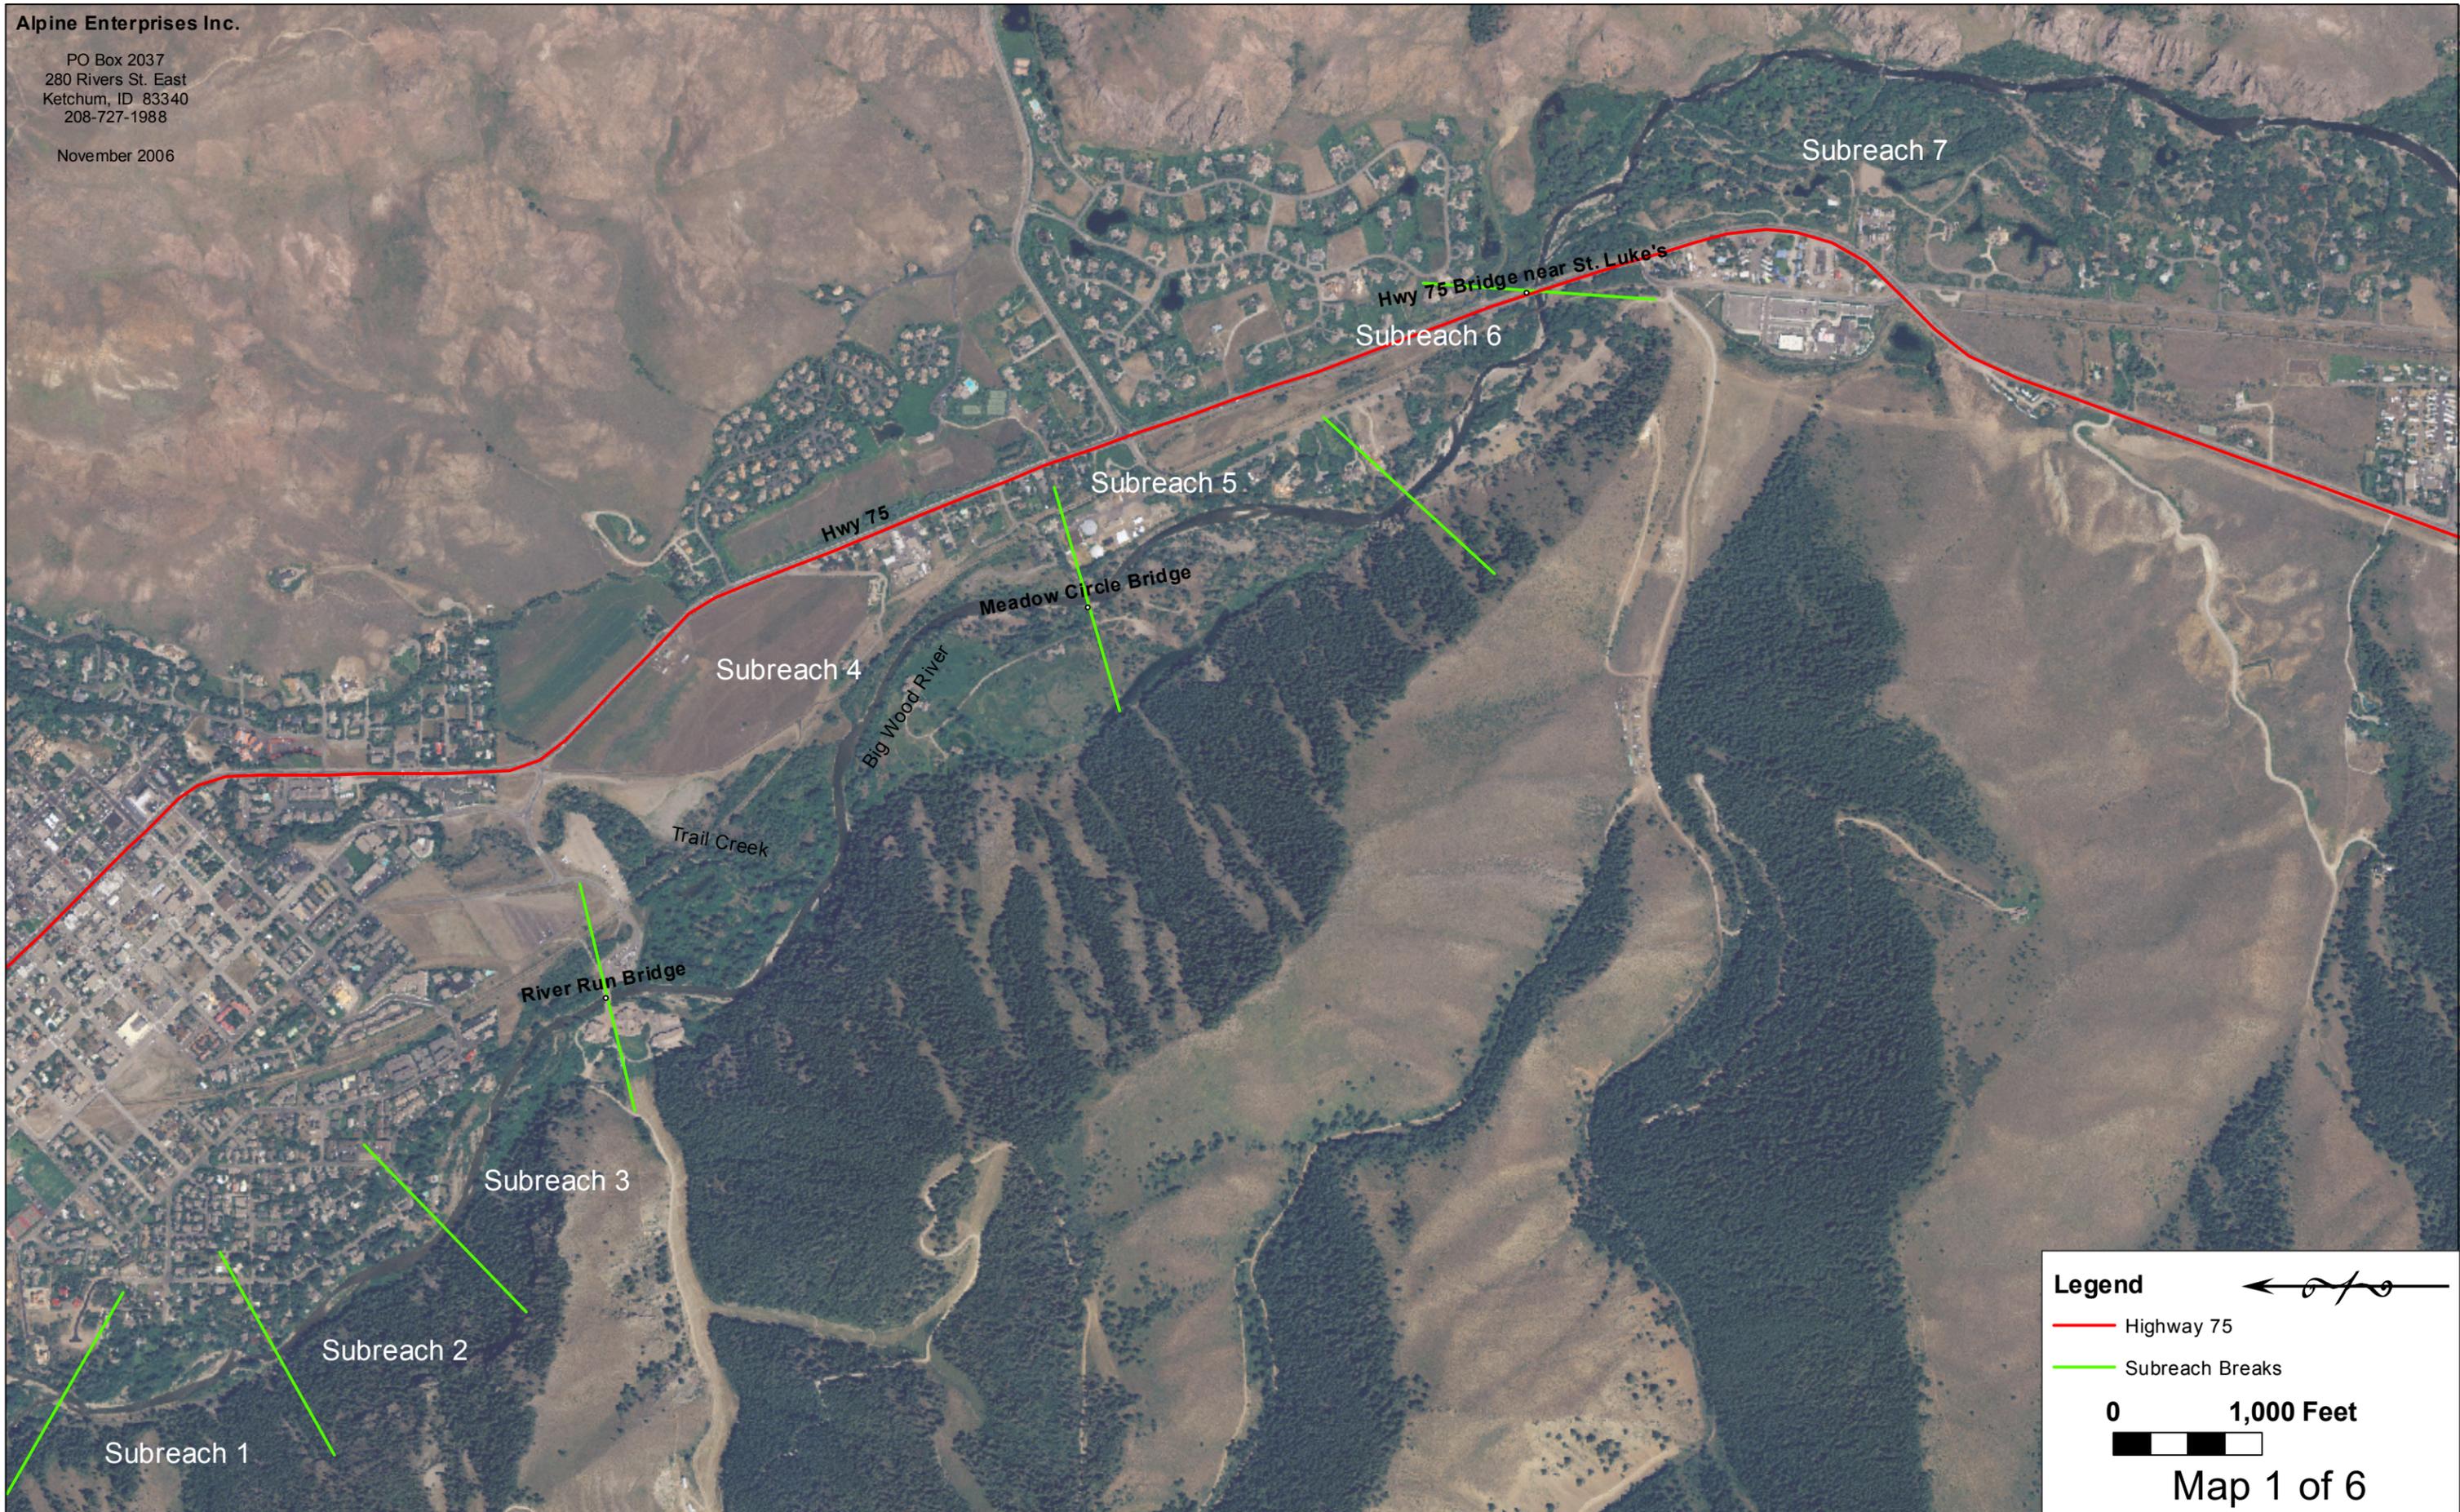
Figure 2 (Sheet 1 of 6). Big Wood River sub-reach boundaries and key features in the study area.

Limited information is available on the geomorphologic characteristics of the watershed and study reach from past work by others. This report represents a first-ever attempt to characterize the geomorphic conditions of the Big Wood River and valley within the study reach. This report assesses geomorphic conditions by delineating the study reach into sub-reaches with similar characteristics, therefore the remainder of this report discusses channel characteristics at a sub-reach level of detail. **Figure 2** presents the limits of the sub-reaches within the overall study reach.

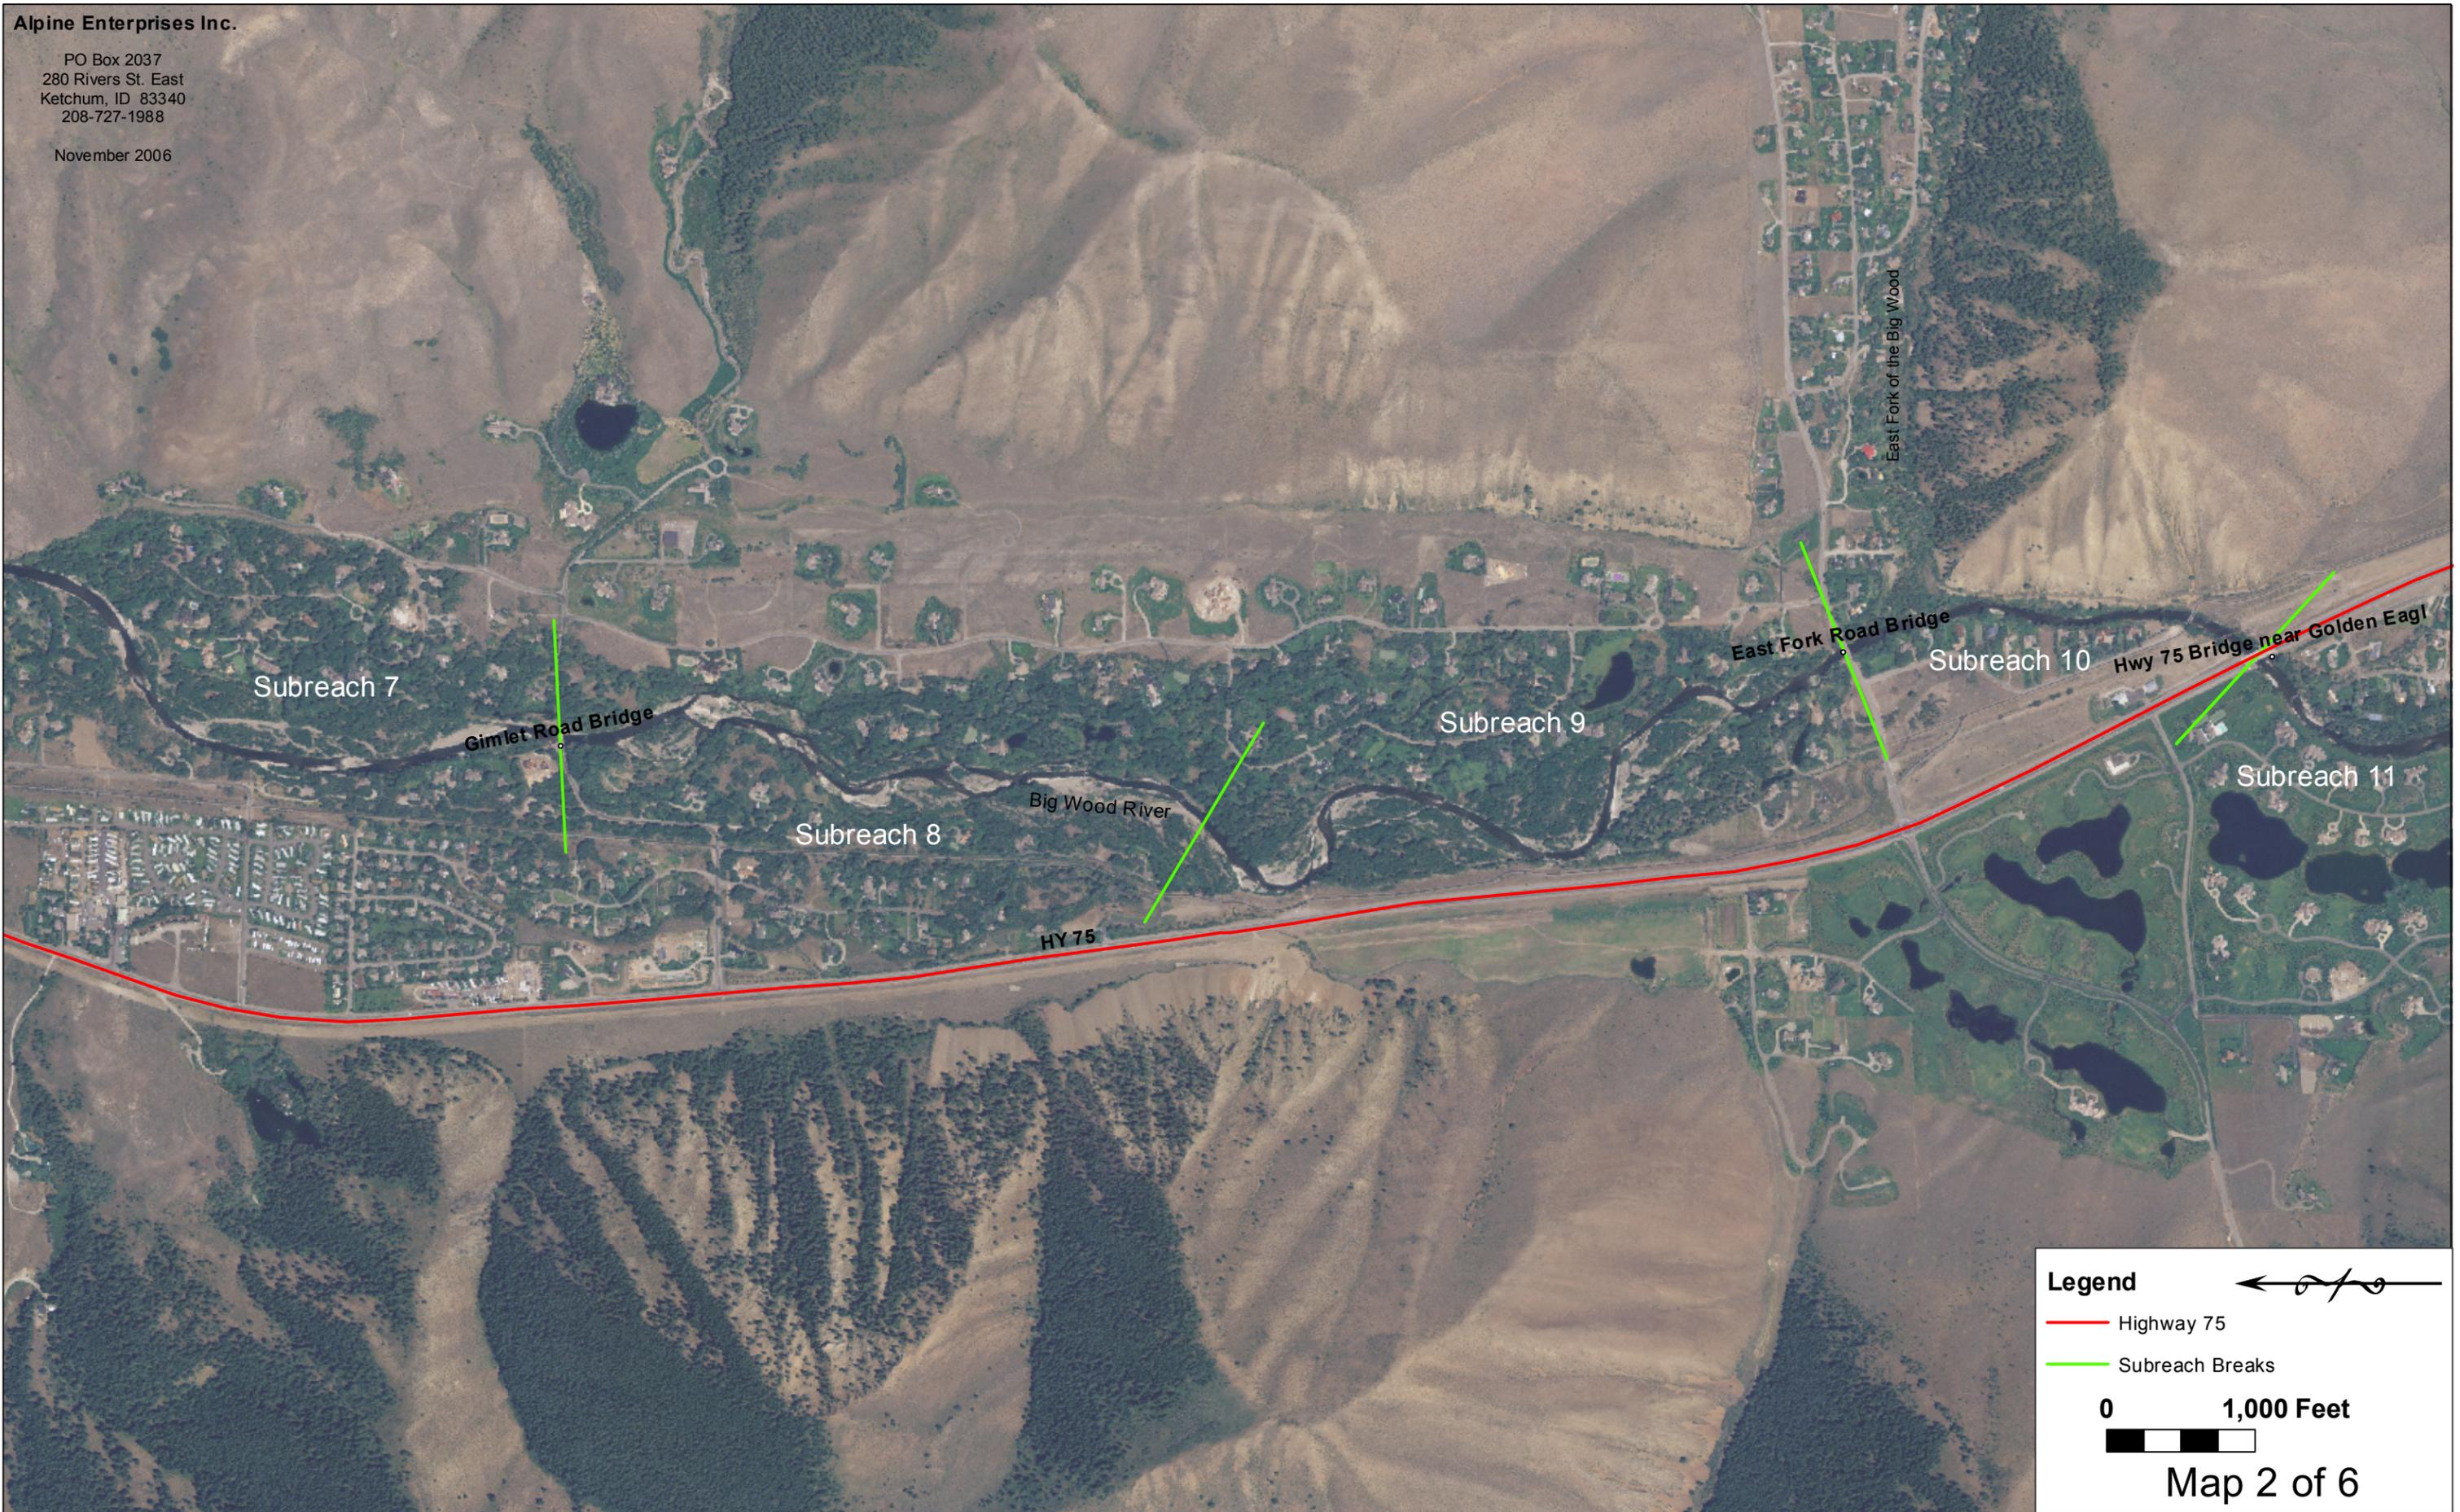
Figure 2 (Sheet 2 of 6). Big Wood River sub-reach boundaries and key features in the study area.

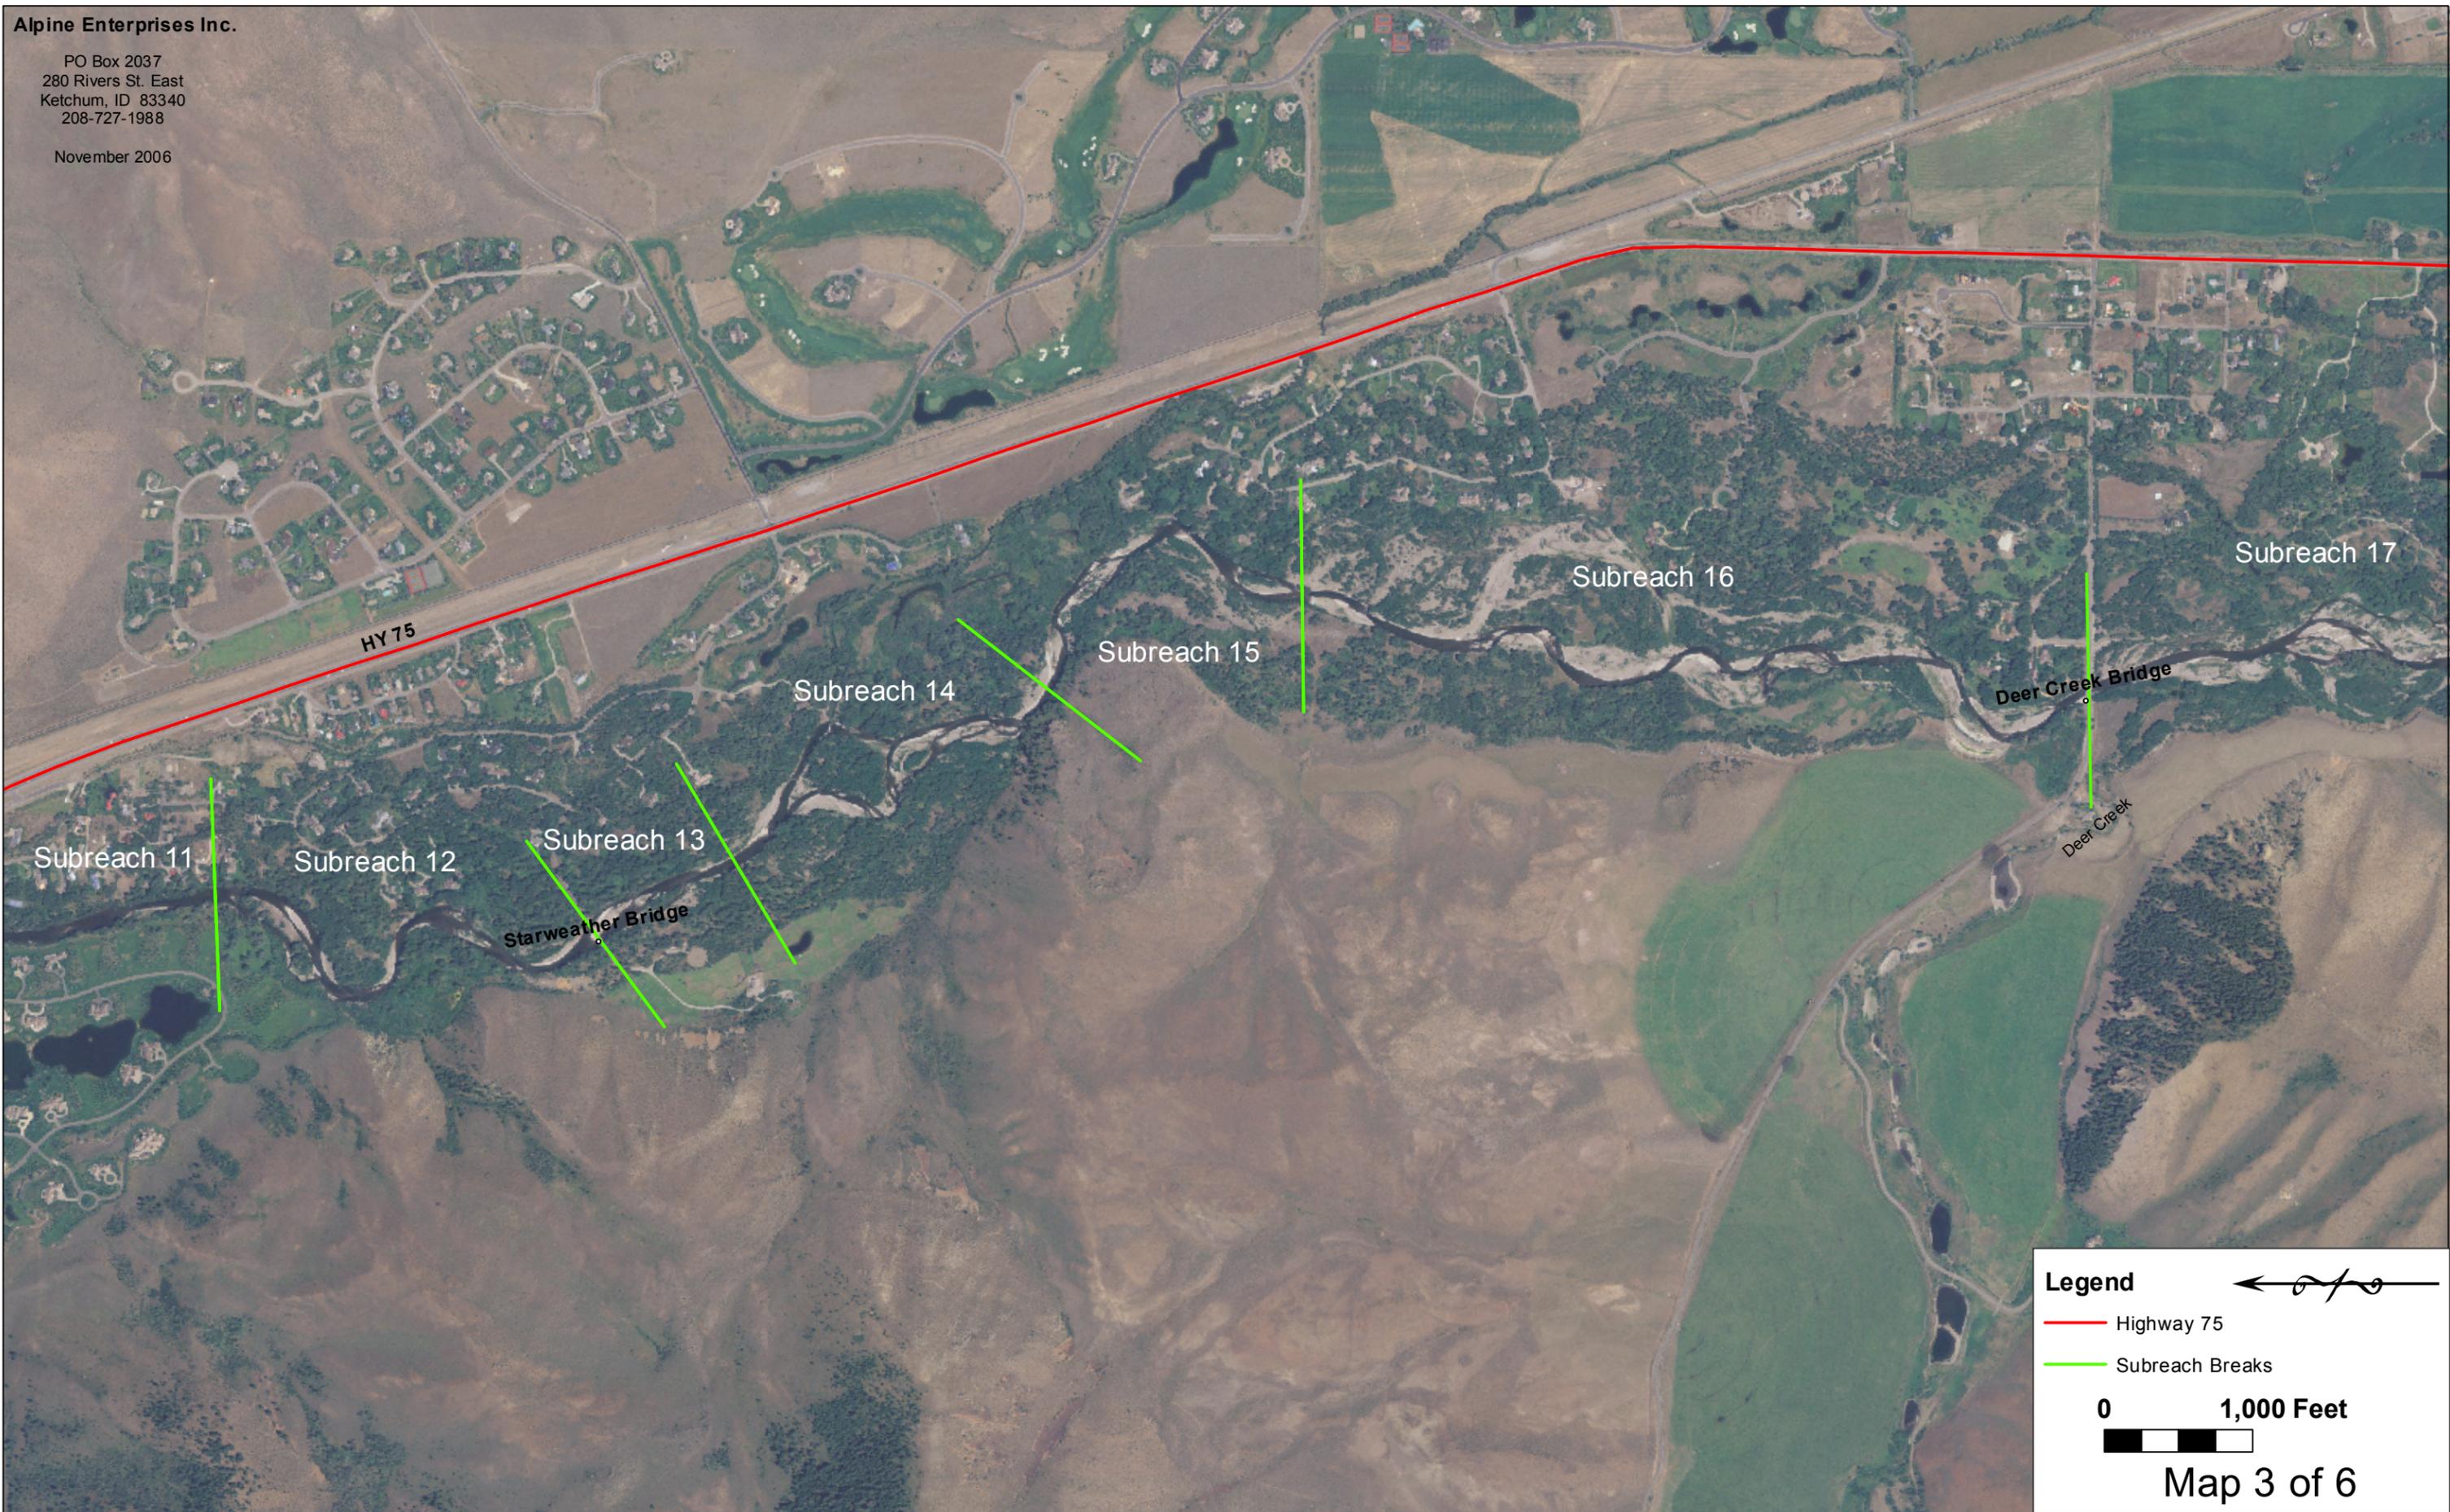
Figure 2 (Sheet 3 of 6). Big Wood River sub-reach boundaries and key features in the study area.

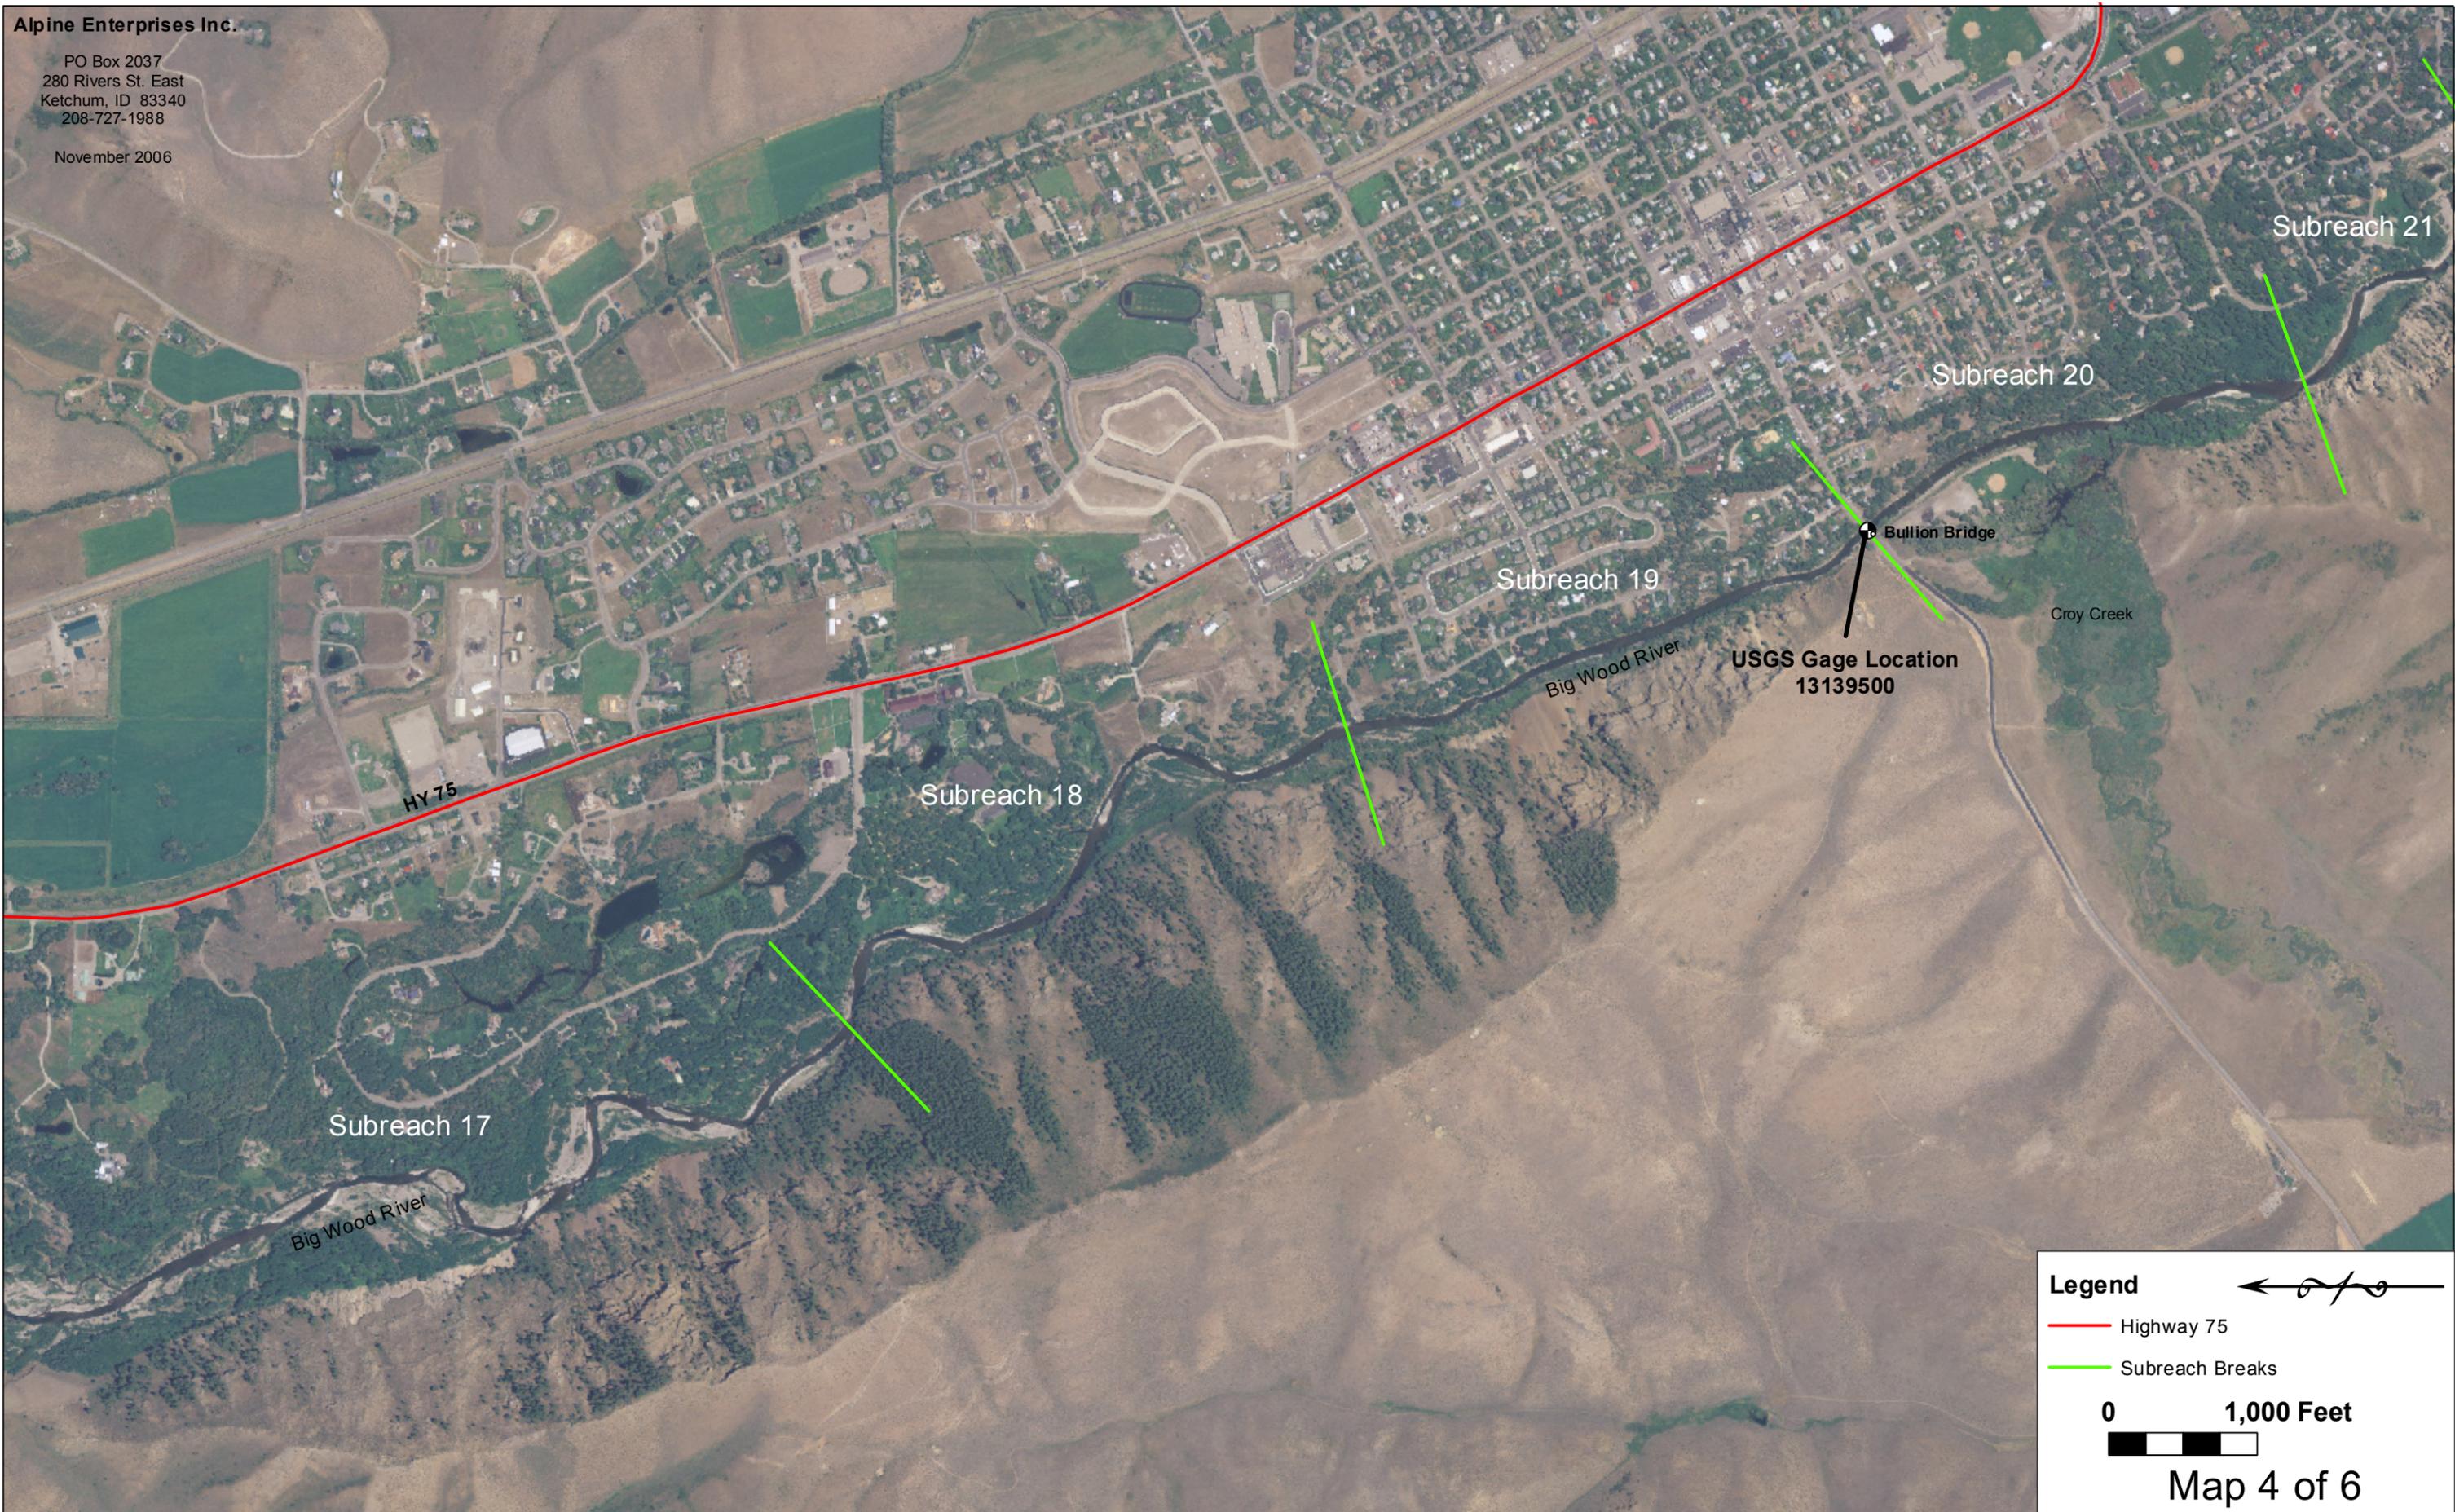
Figure 2 (Sheet 4 of 6). Big Wood River sub-reach boundaries and key features in the study area.

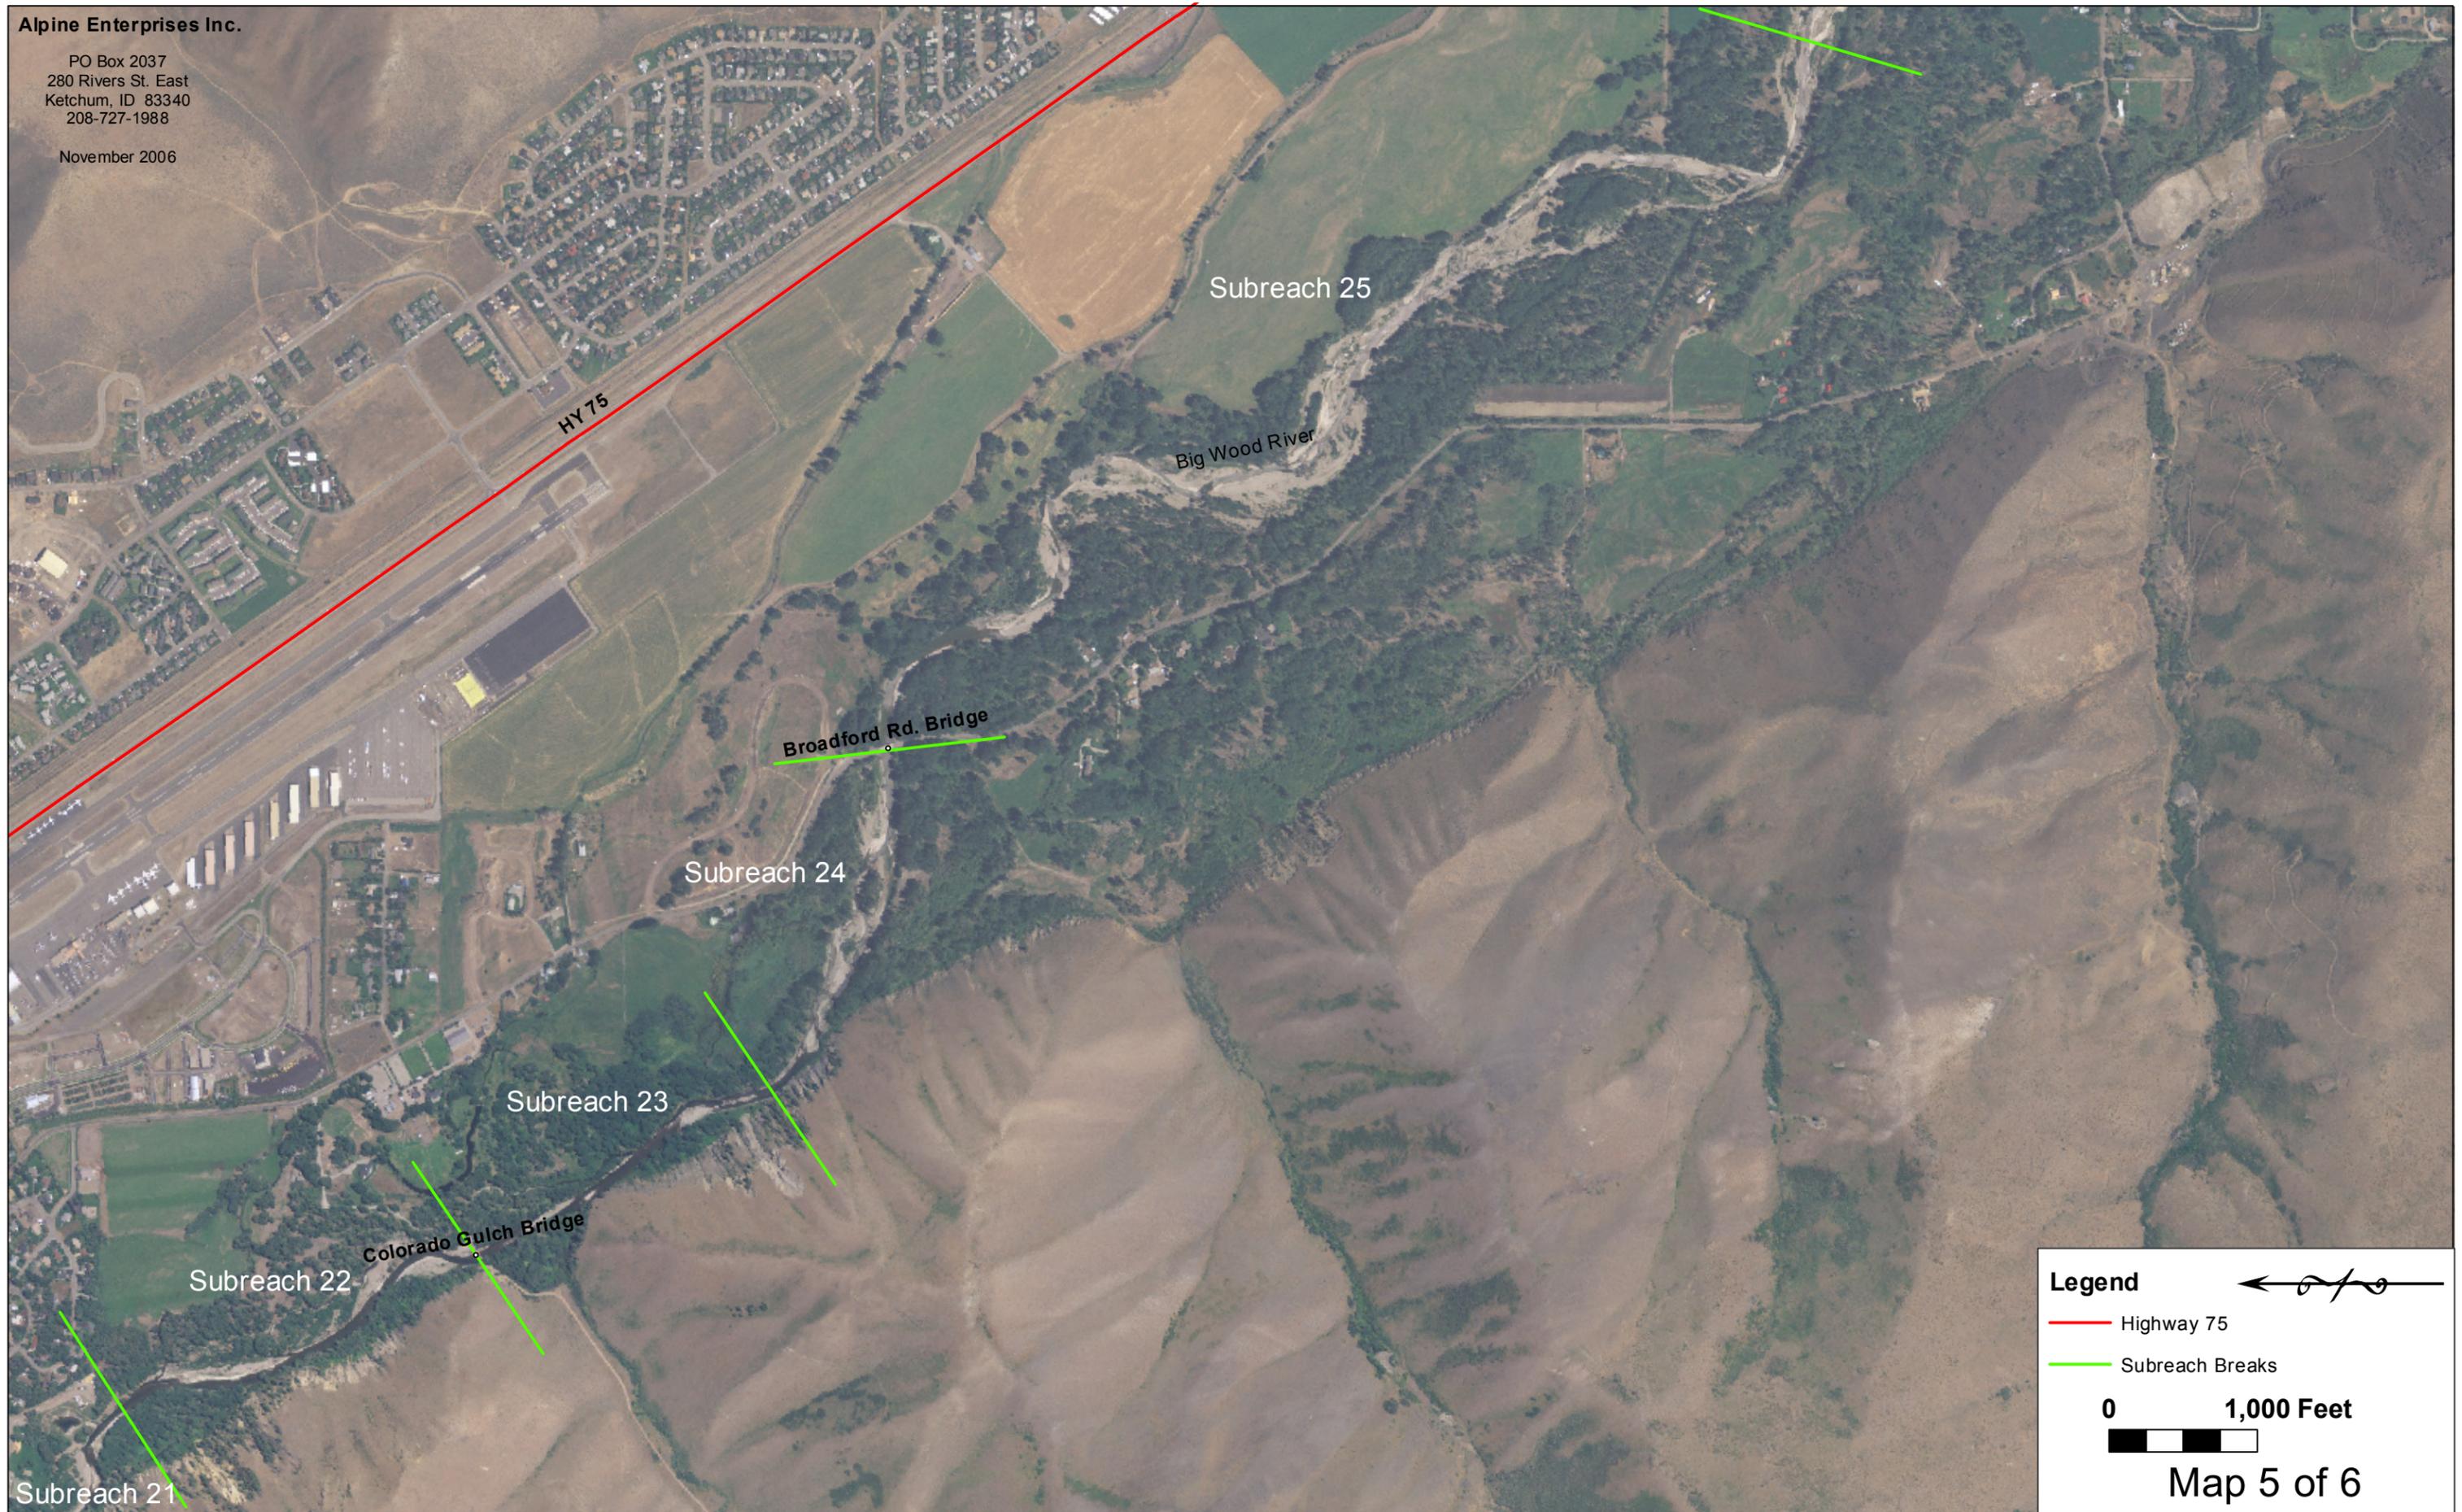
Map 5 of 6

Figure 2 (Sheet 5 of 6). Big Wood River sub-reach boundaries and key features in the study area.

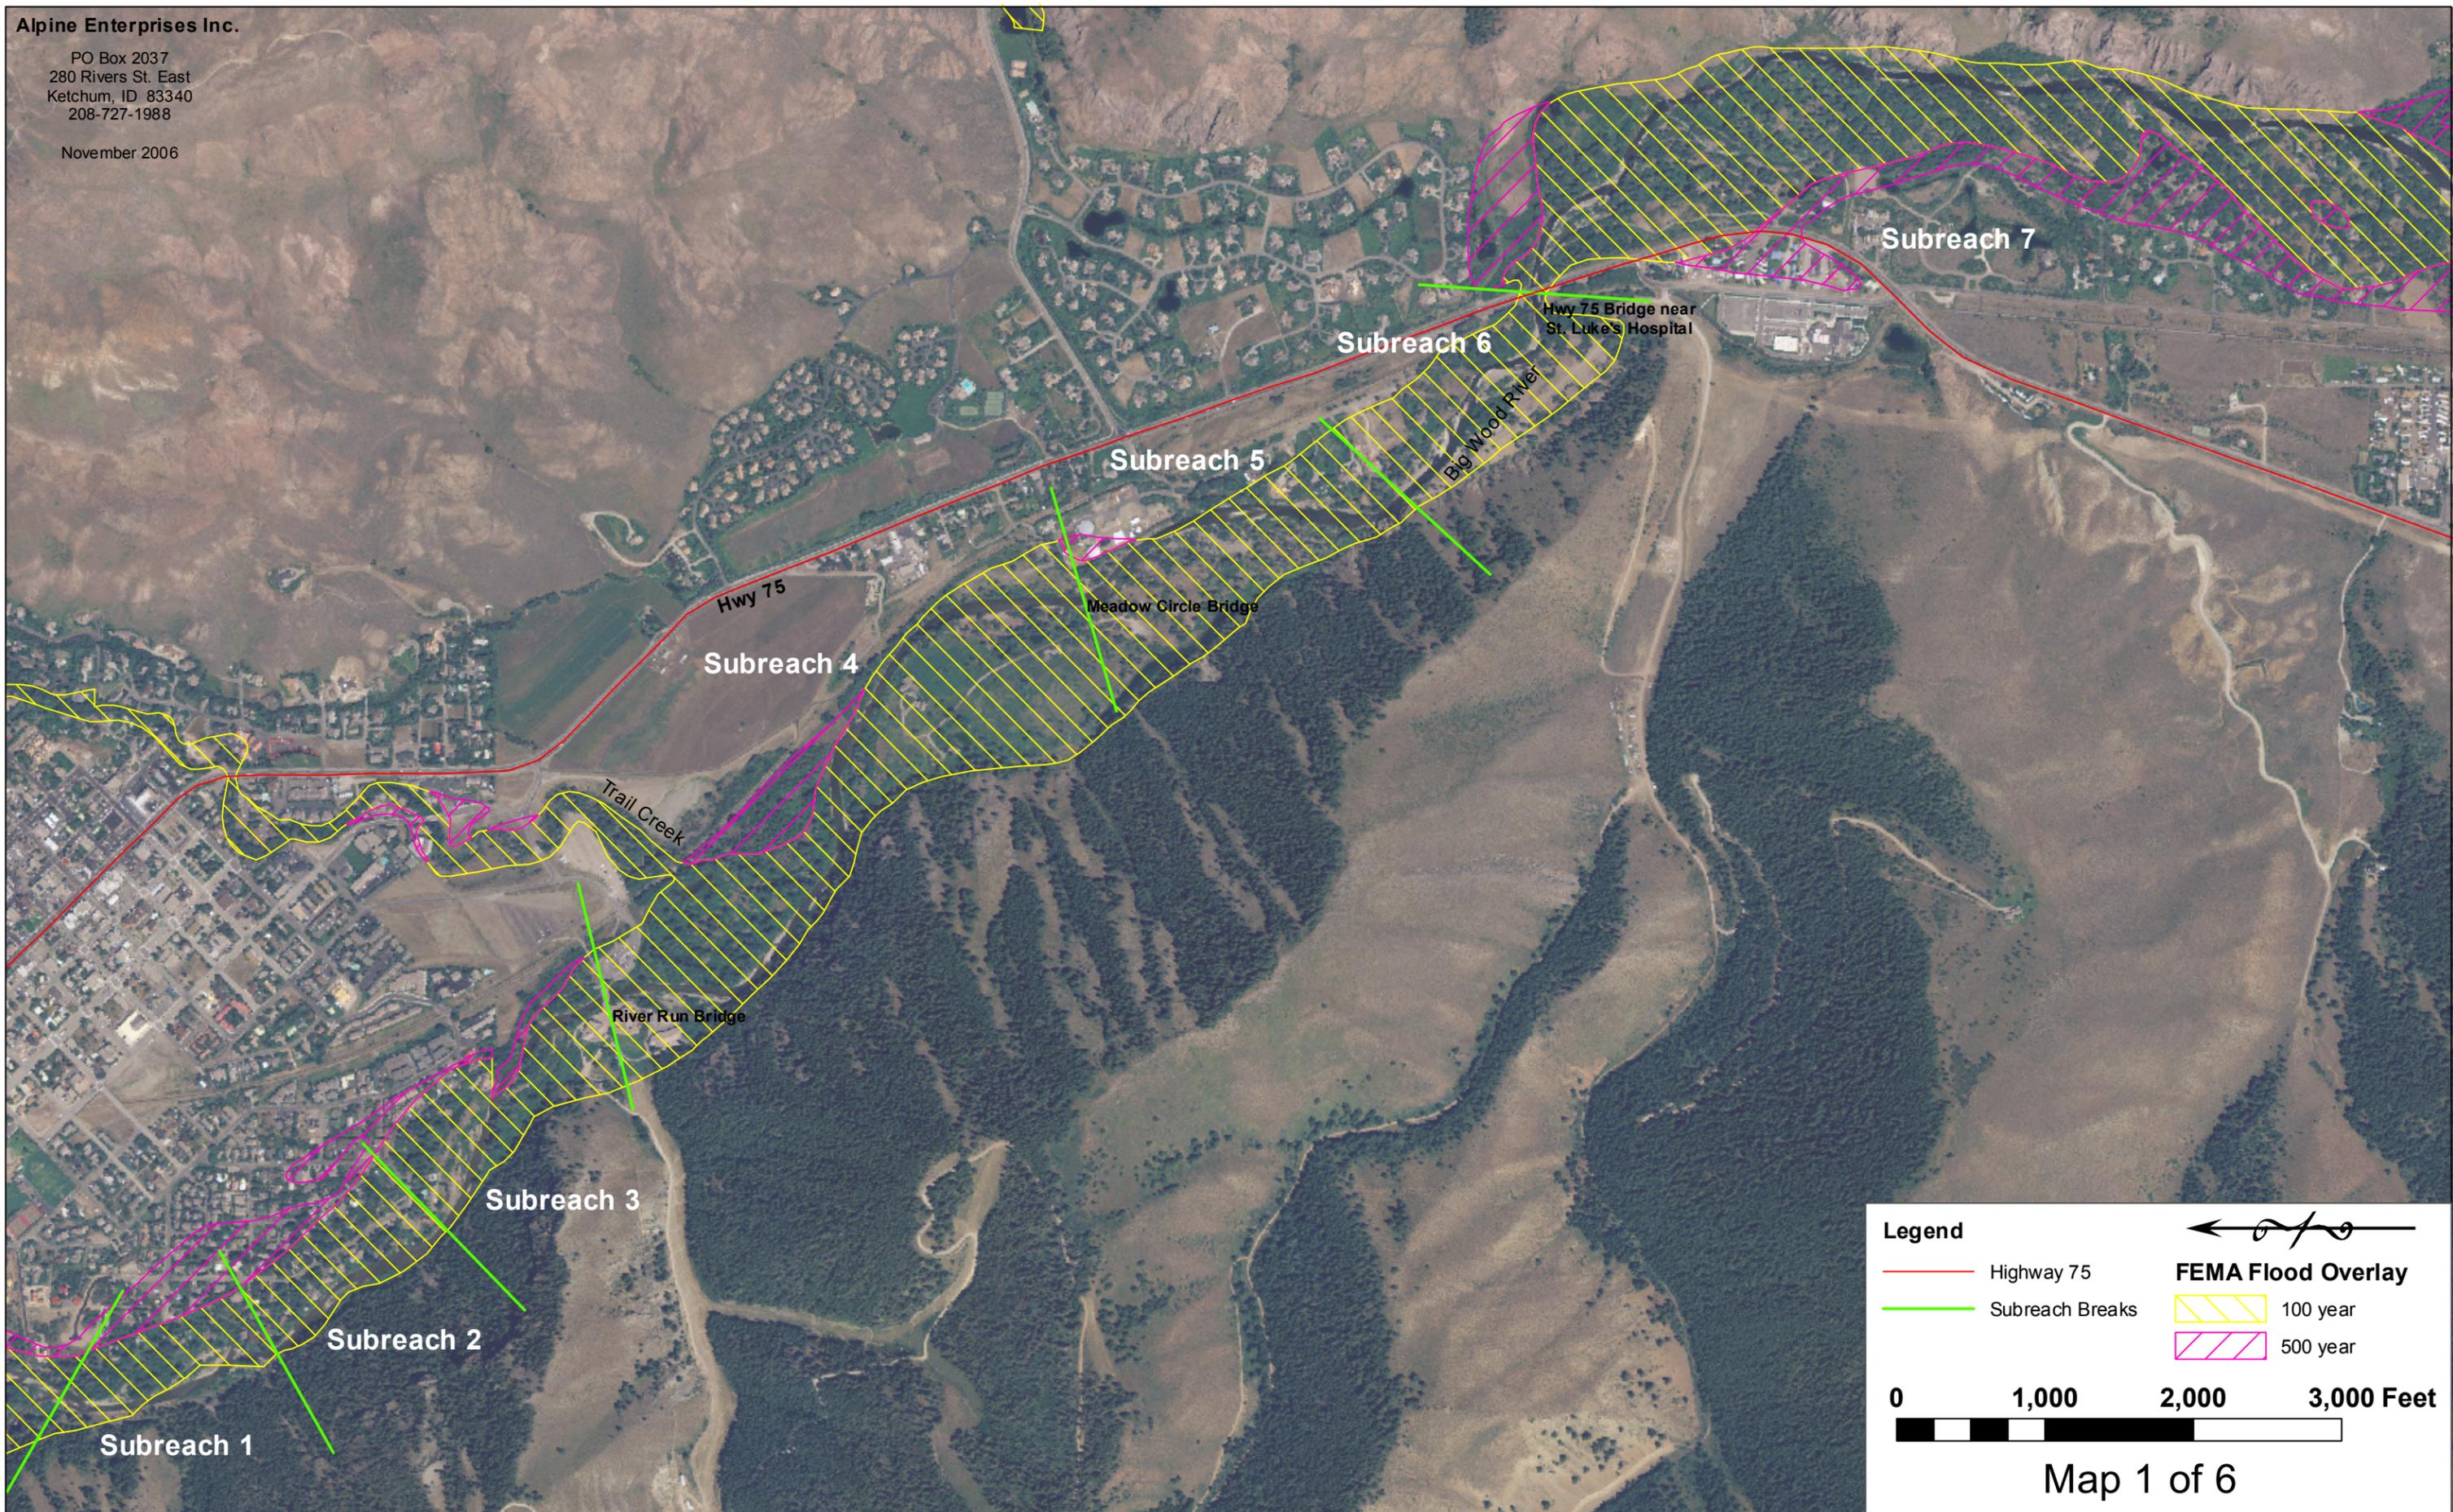
Figure 3 (Sheet 1 of 6). Big Wood River floodplain boundaries within the study reach as mapped by FEMA

FEMA published floodplain maps for the 100-year and 500-year recurrence intervals in 1998 based on cross section data measured in 1994 covering the entire study reach. FEMA's floodplain mapping is likely out of date, given that mapping efforts pre-date channel changes that occurred during the 1997 and 2006 floods. However, the results are useful as a preliminary benchmark for determining the extent of flooding and potential erosion hazards in the study area.
