GEOMORPHIC ASSESSMENT OF THE BIG WOOD RIVER

**River Mile 79.5 (Glendale Diversion) to River Mile 100.05
(Confluence with Warm Springs Creek)**

Prepared for
Wood River Land Trust

December 2006

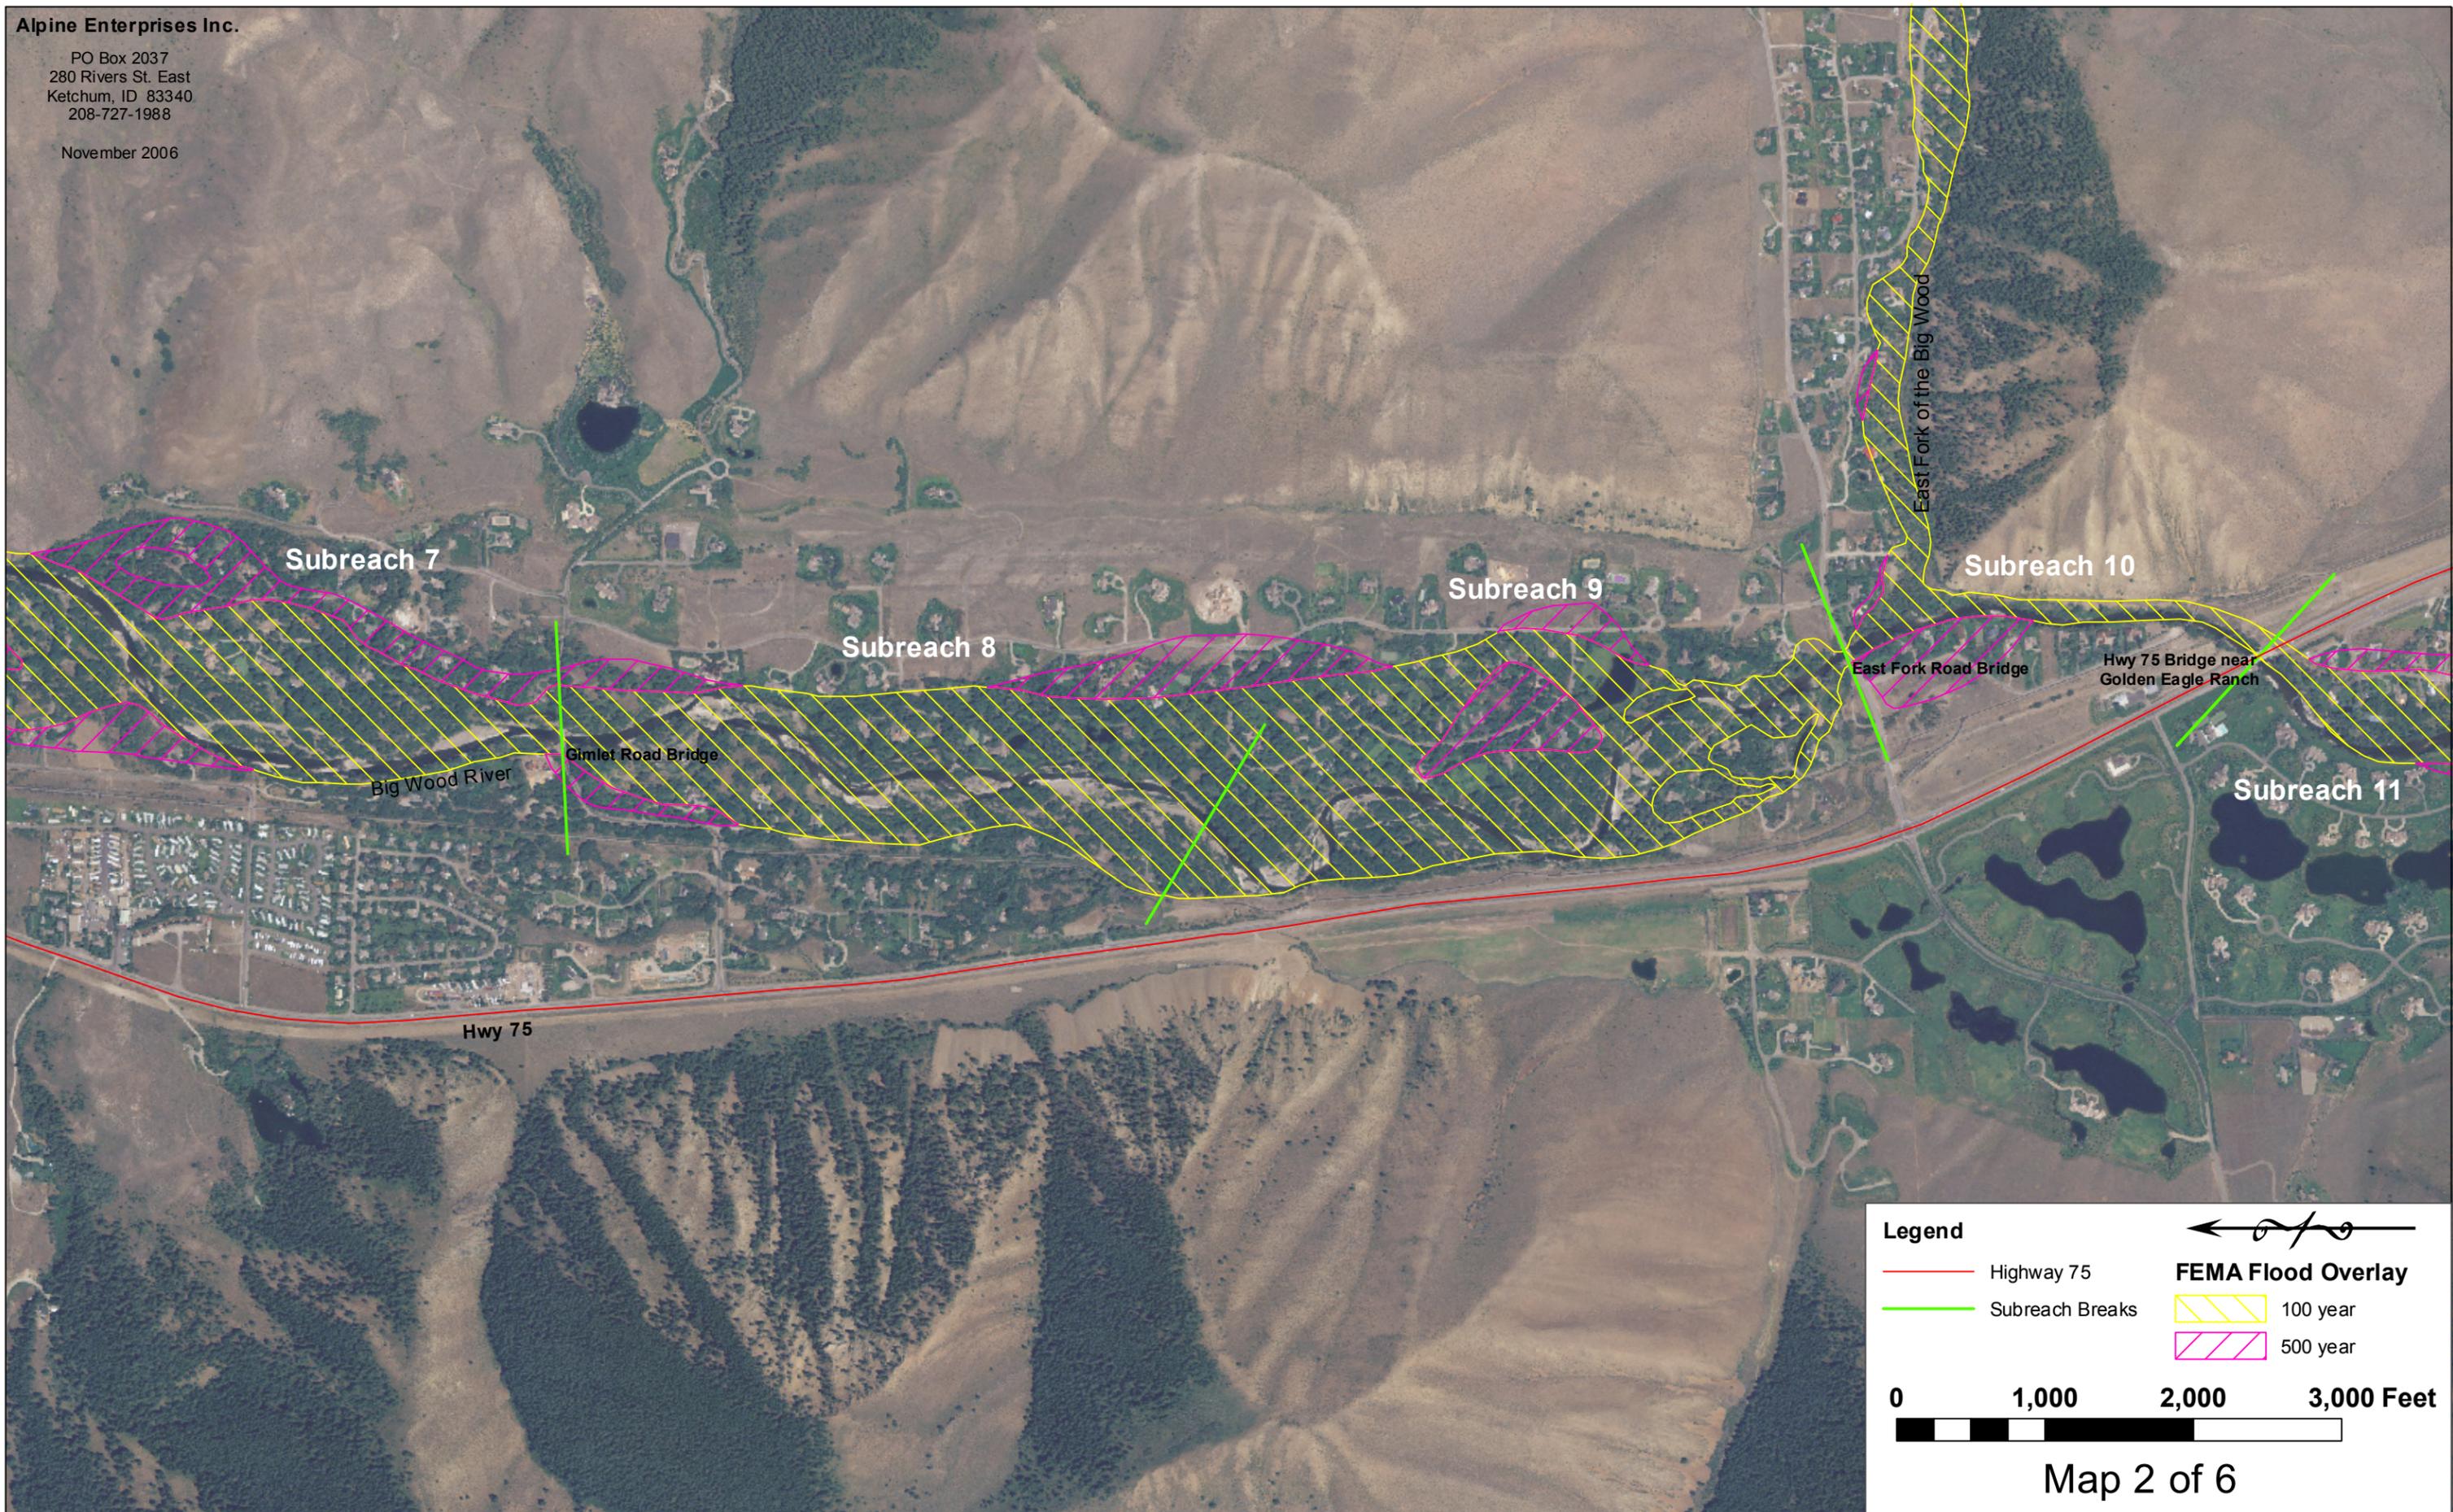
Figure 3 (Sheet 2 of 6). Big Wood River floodplain boundaries within the study reach as mapped by FEMA.

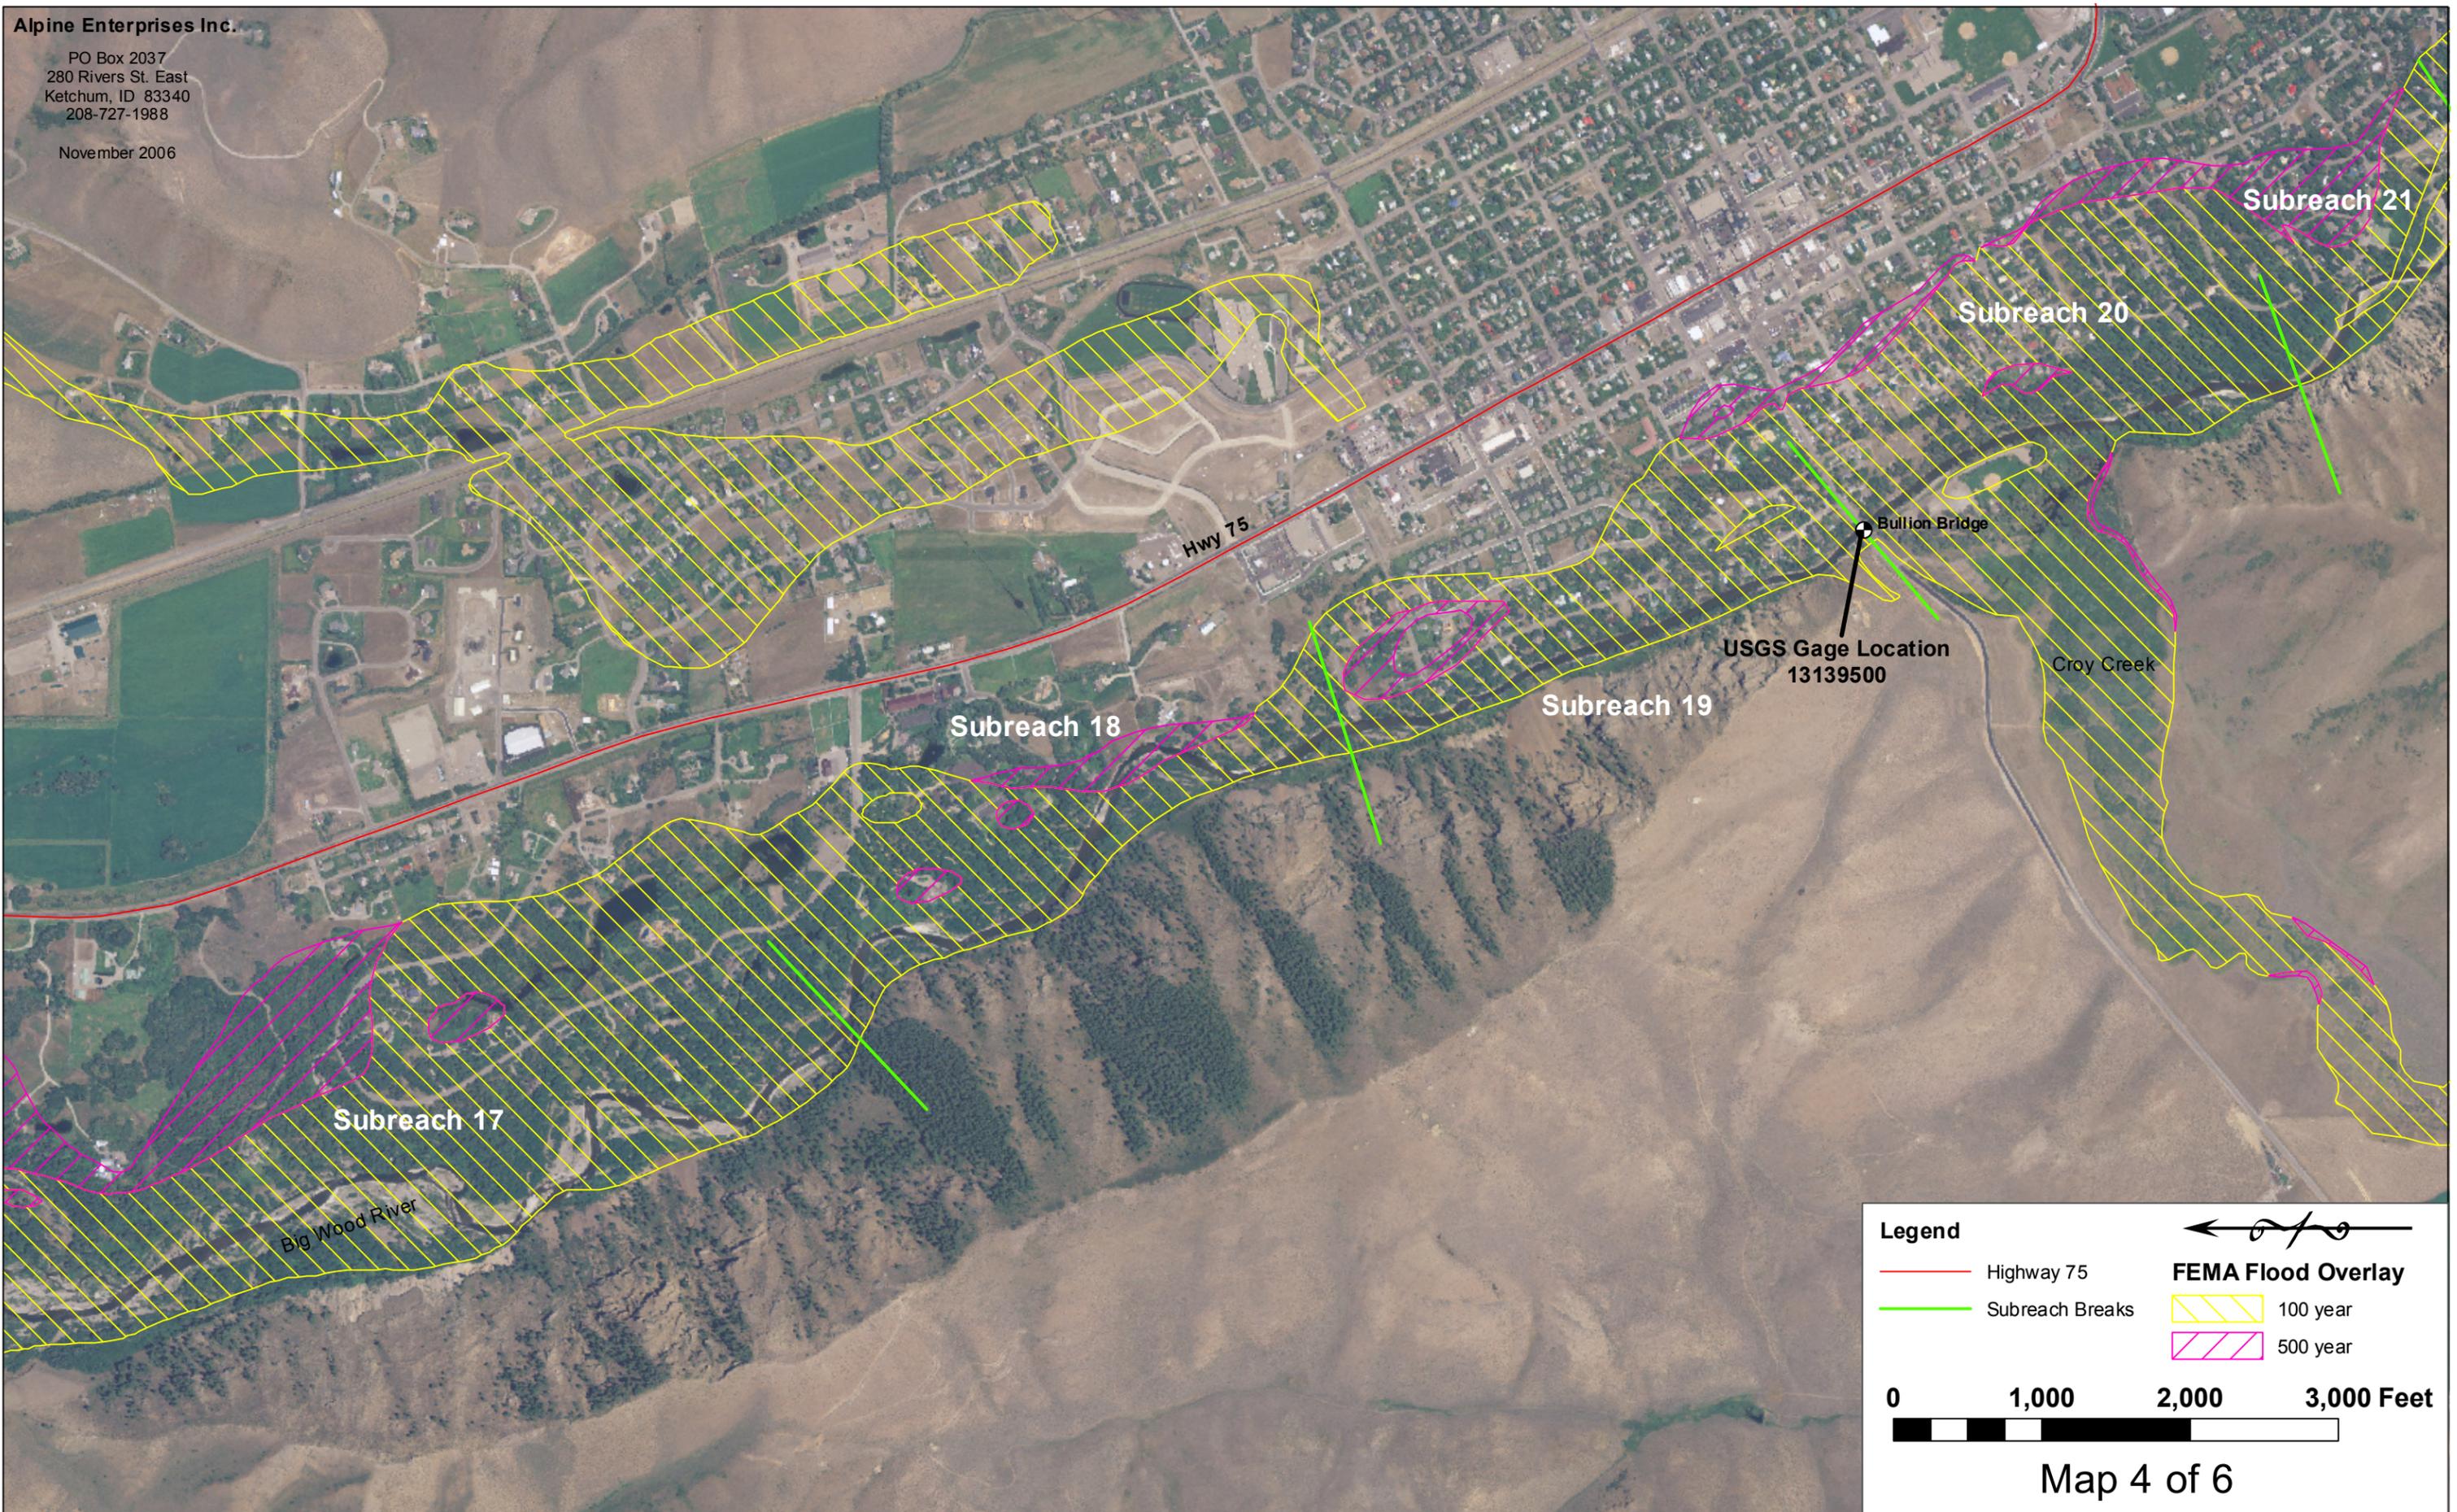
Figure 3 (Sheet 4 of 6). Big Wood River floodplain boundaries within the study reach as mapped by FEMA.

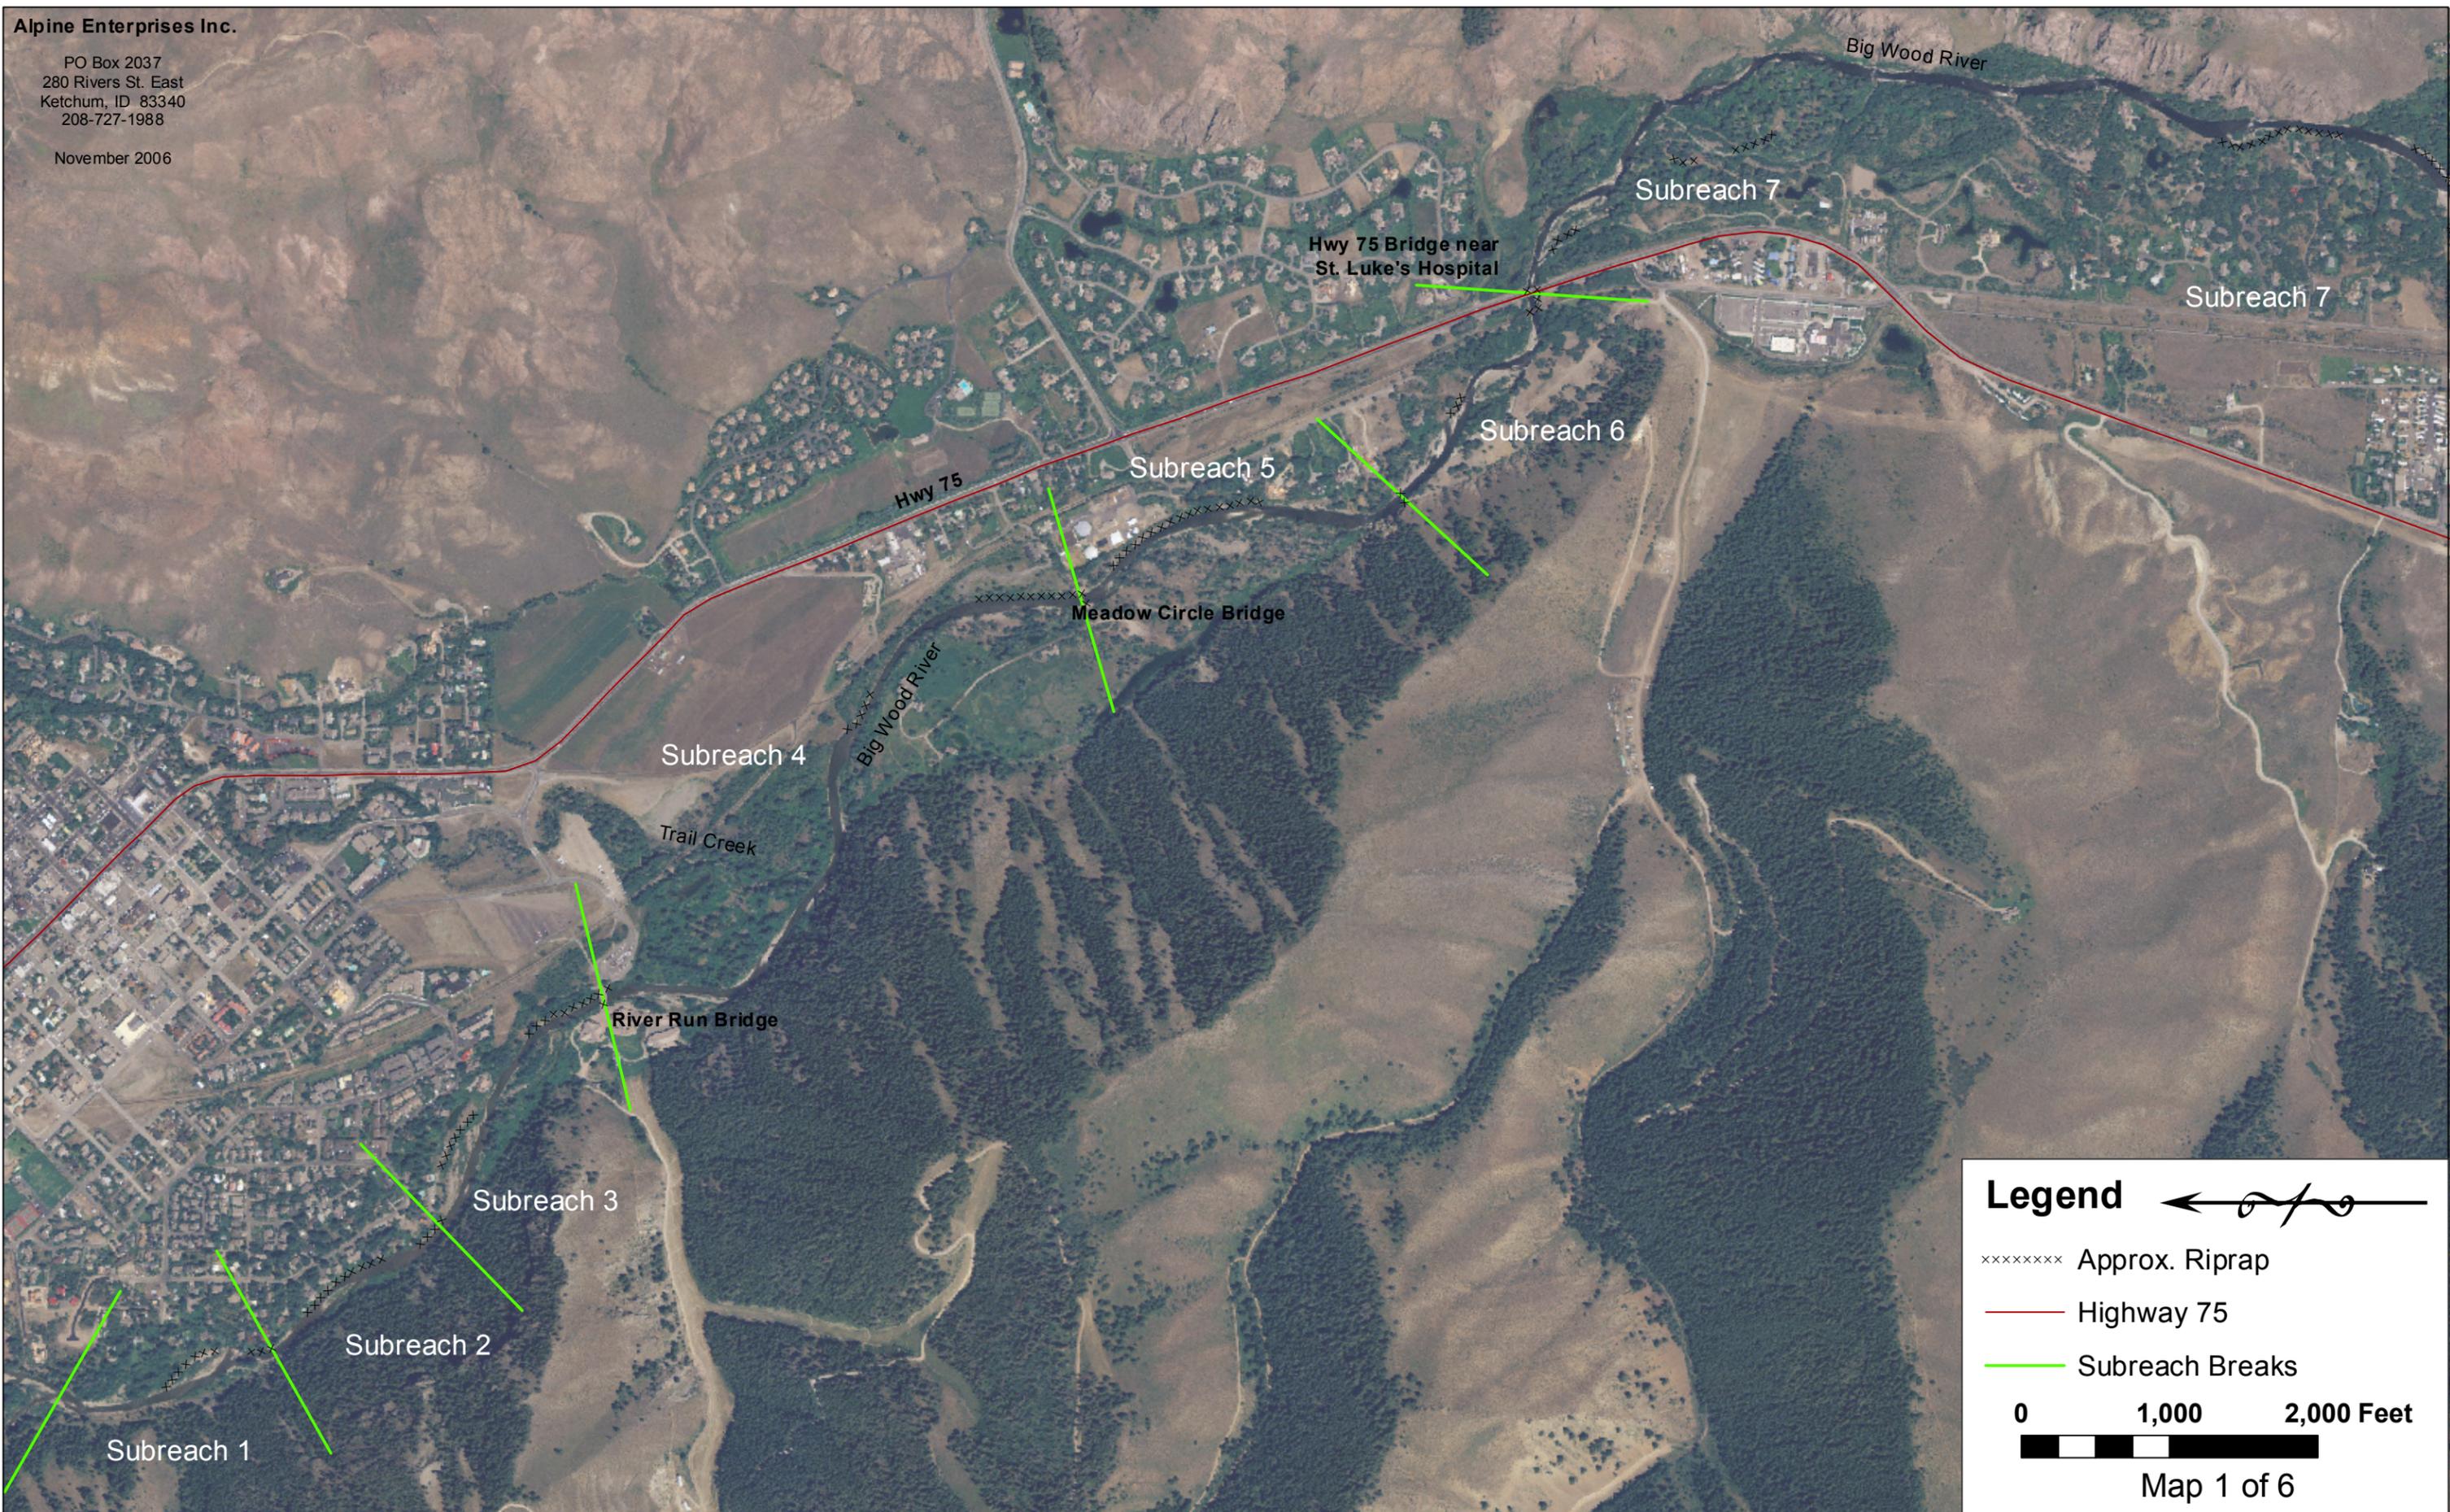
Figure 5 (Sheet 1 of 6). Results of the preliminary bank hardening survey for the Big Wood River within the study reach.

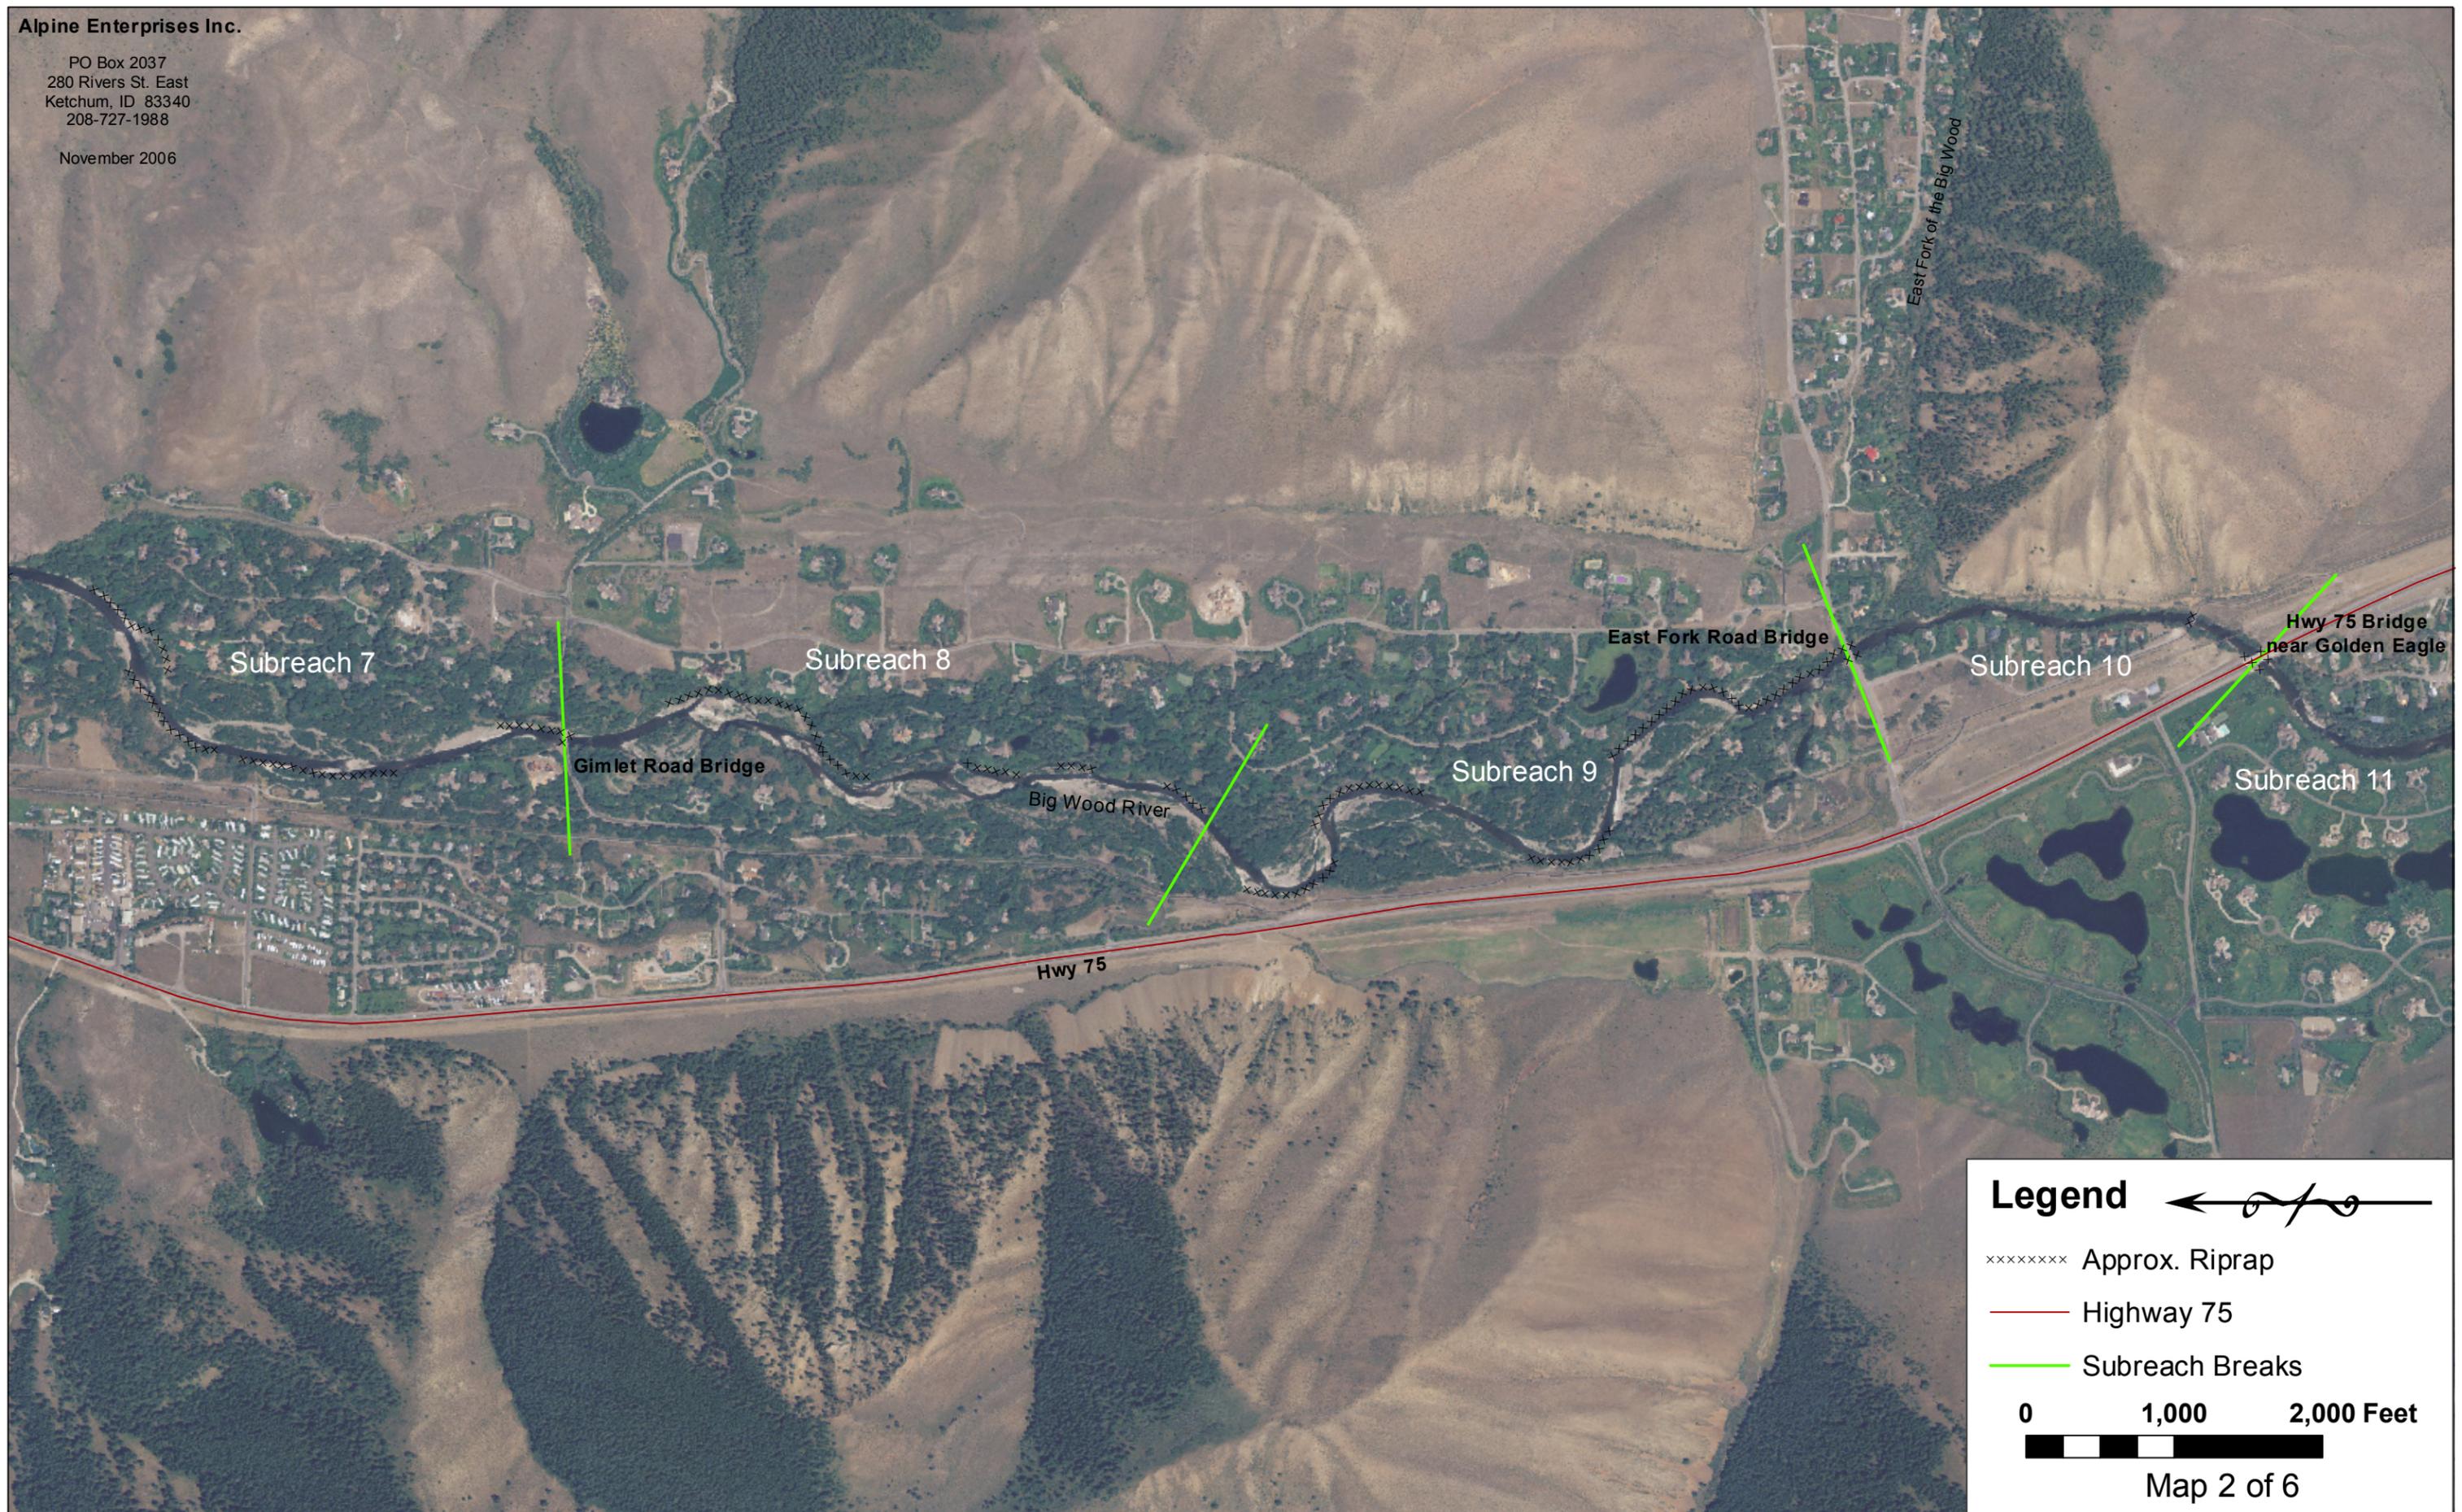
Map 2 of 6

Figure 5 (Sheet 2 of 6). Results of the preliminary bank hardening survey for the Big Wood River within the study reach.

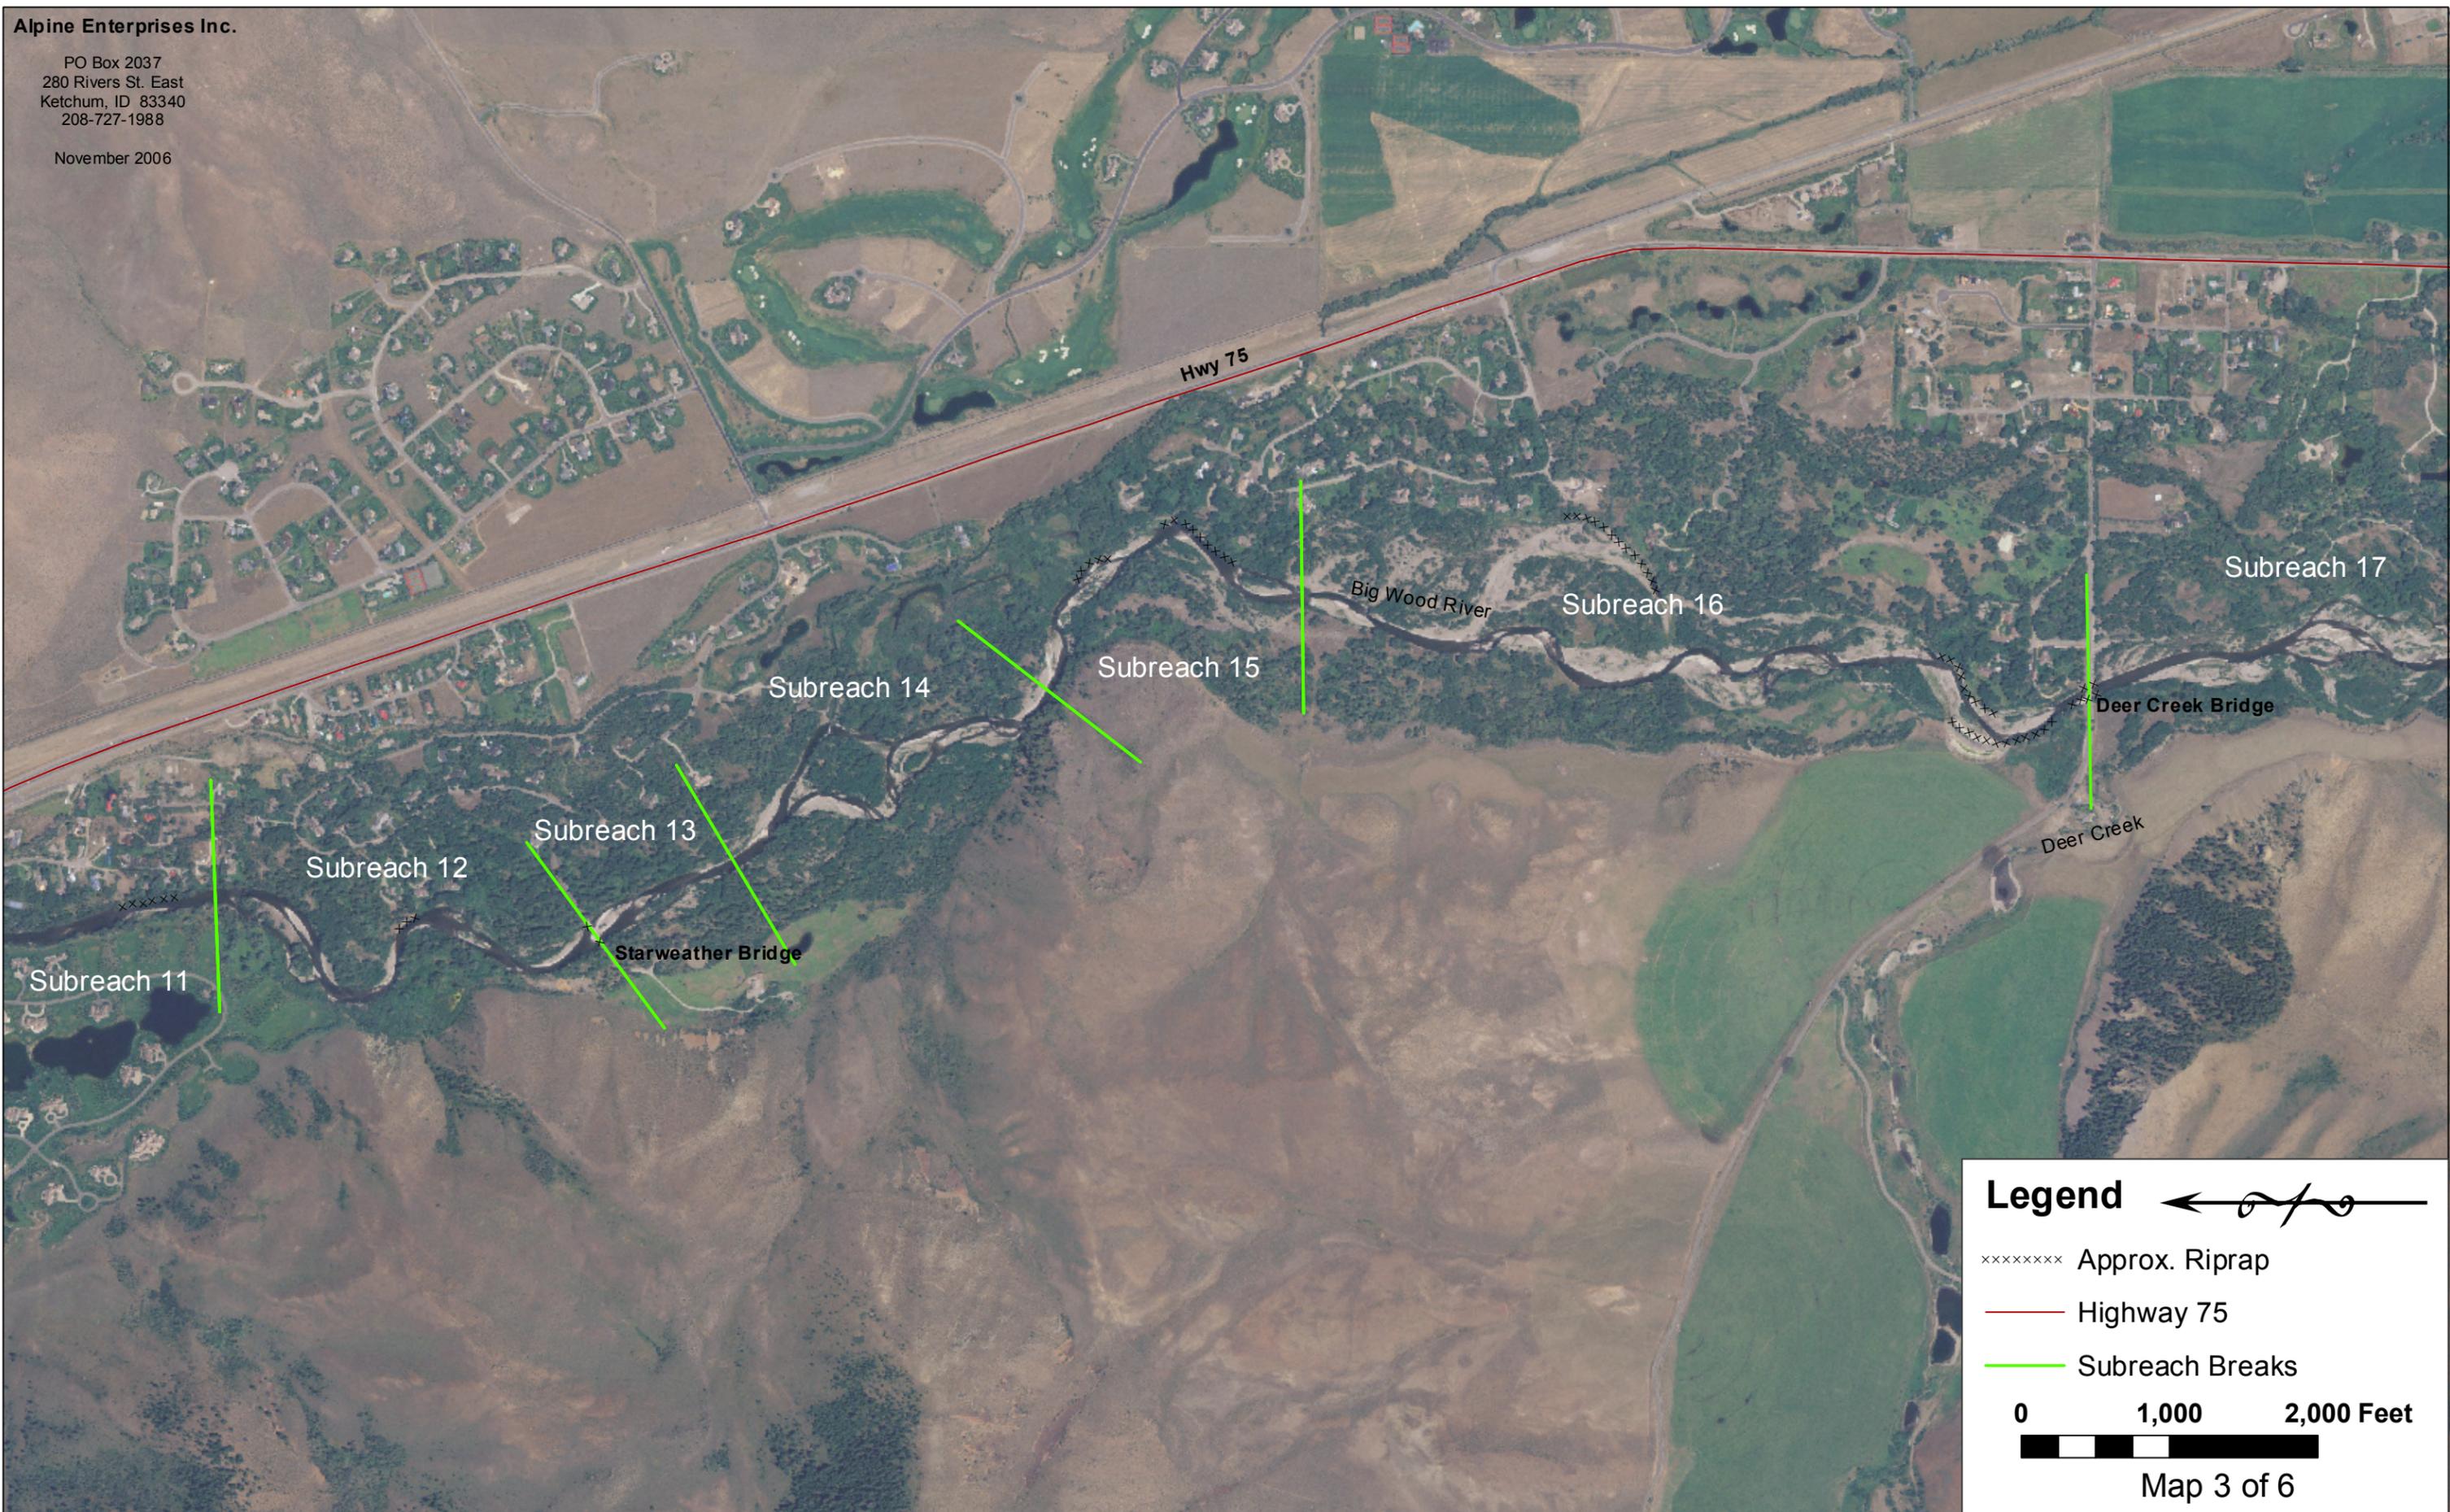
Figure 5 (Sheet 3 of 6). Results of the preliminary bank hardening survey for the Big Wood River within the study reach.

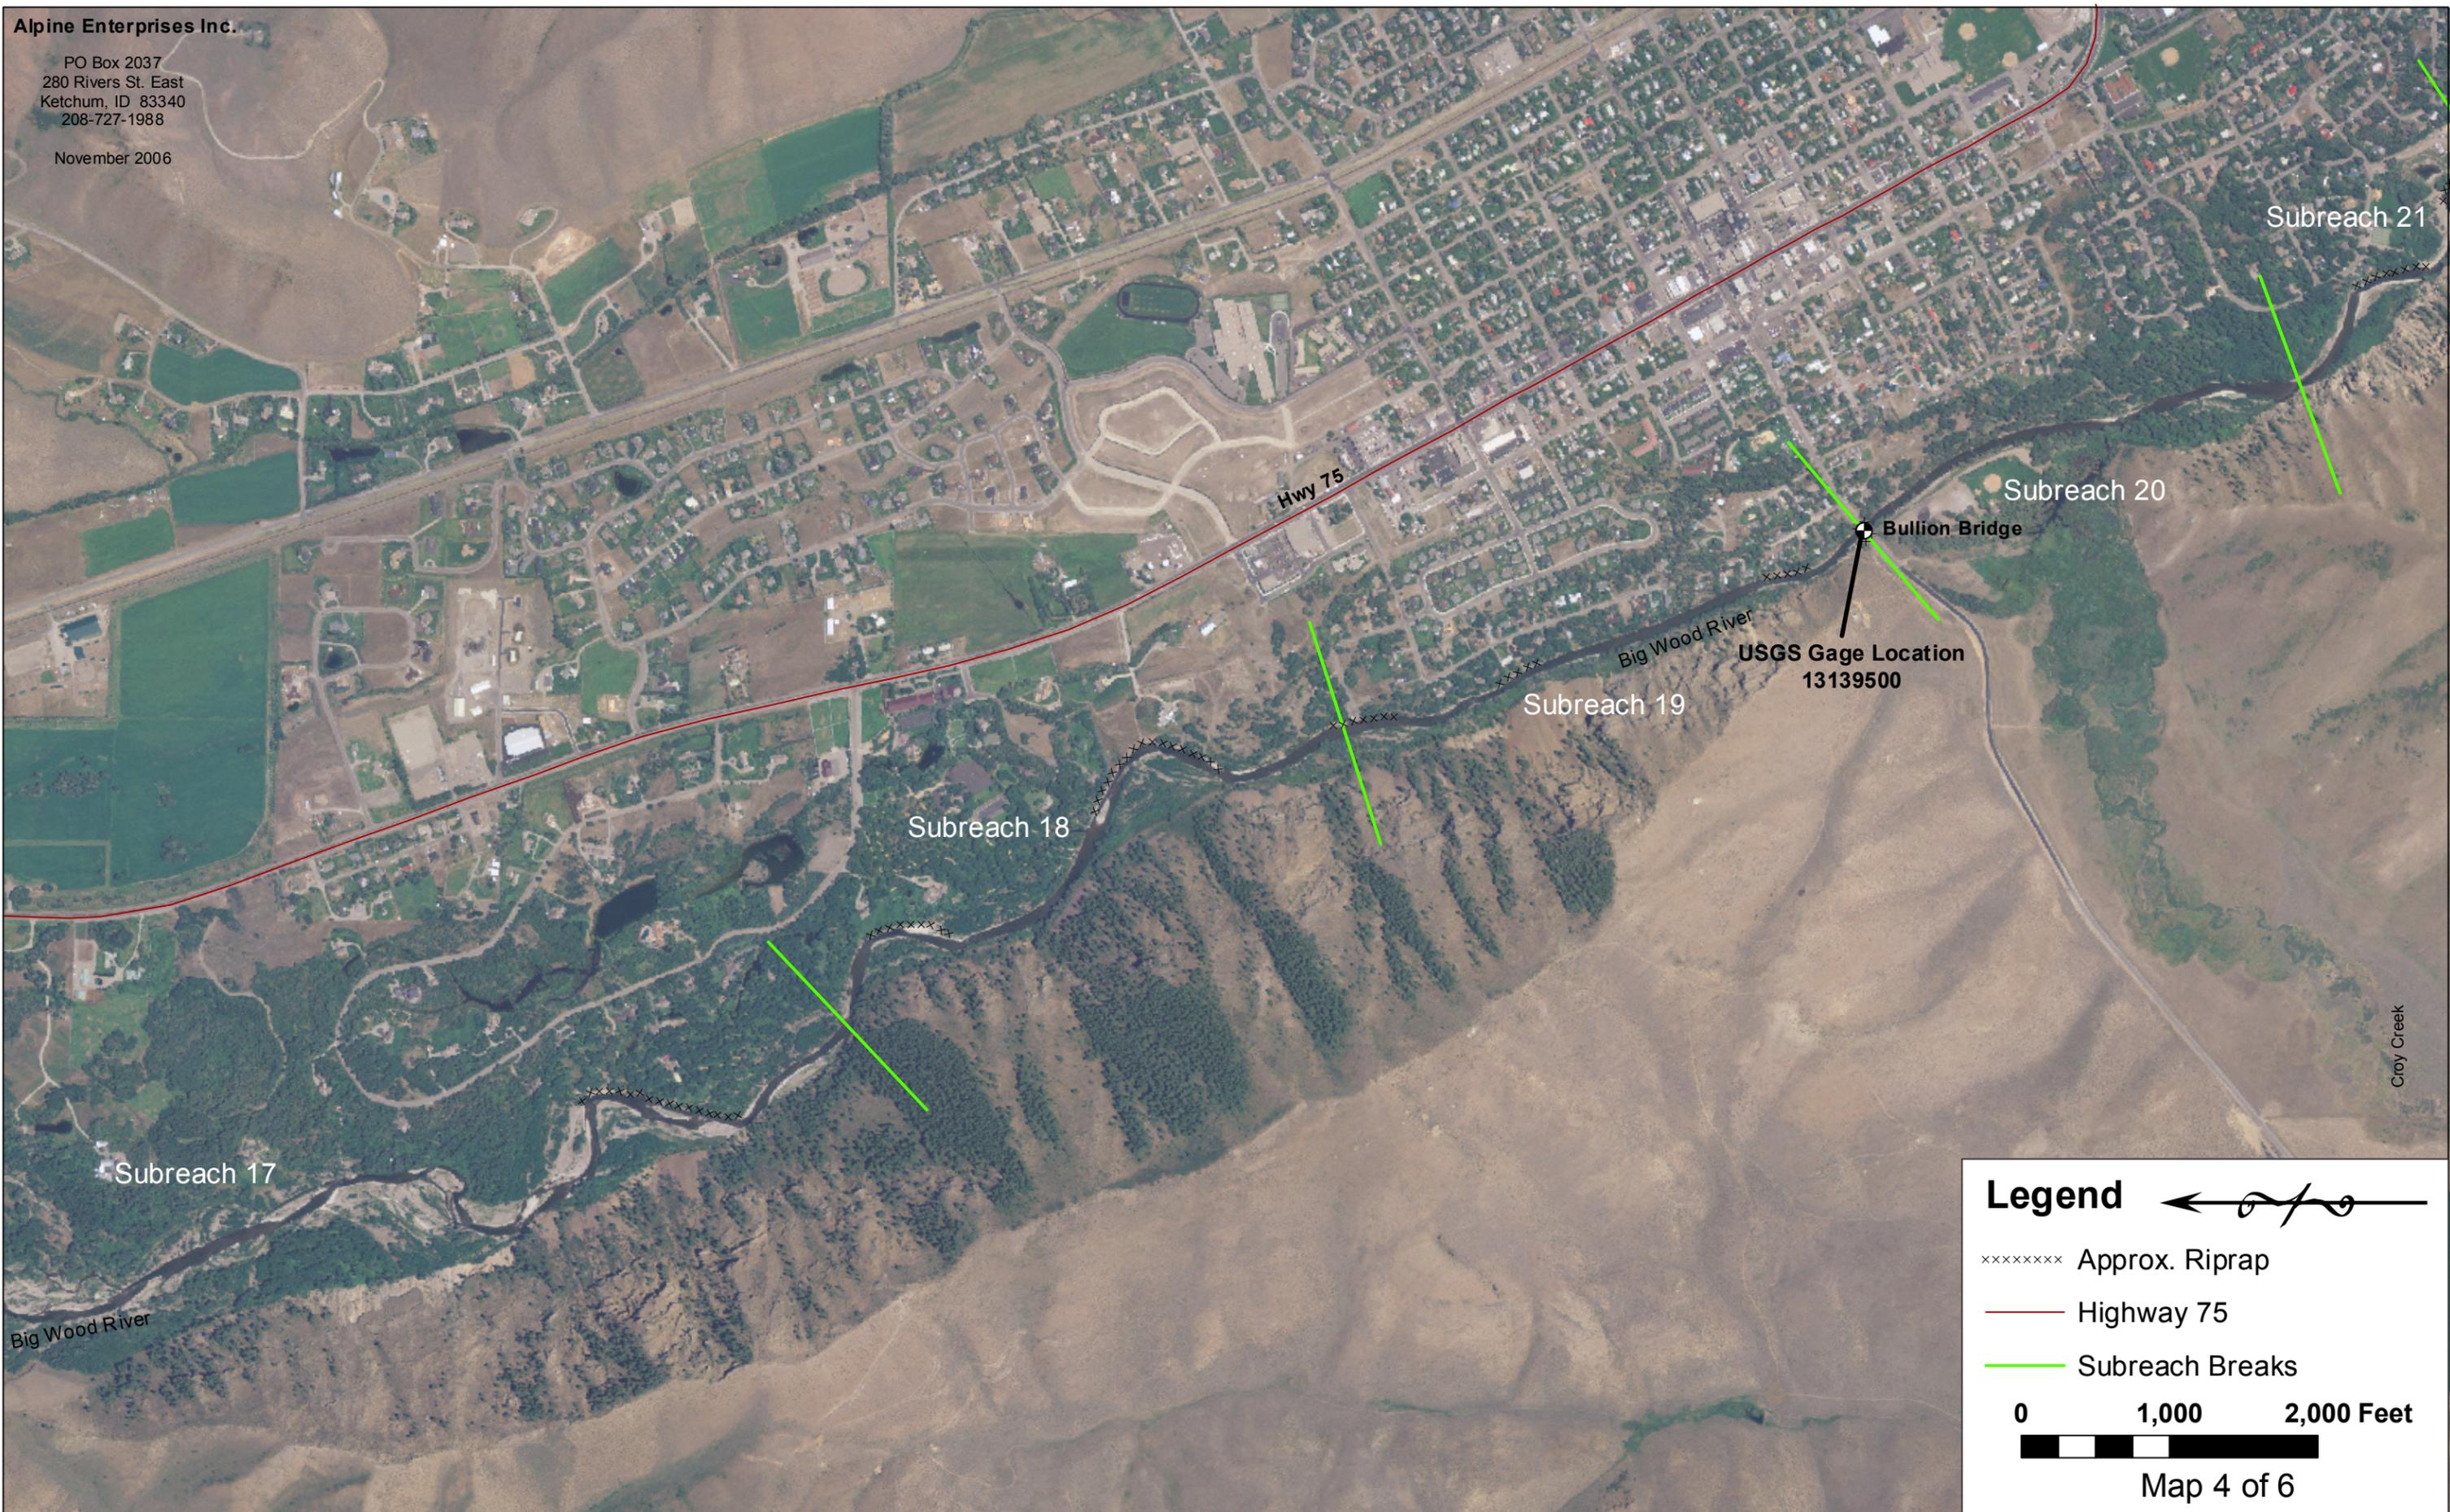
Figure 5 (Sheet 4 of 6). Results of the preliminary bank hardening survey for the Big Wood River within the study reach.
