GEOMORPHIC ASSESSMENT OF THE BIG WOOD RIVER

**River Mile 79.5 (Glendale Diversion) to River Mile 100.05
(Confluence with Warm Springs Creek)**

Prepared for
Wood River Land Trust

December 2006

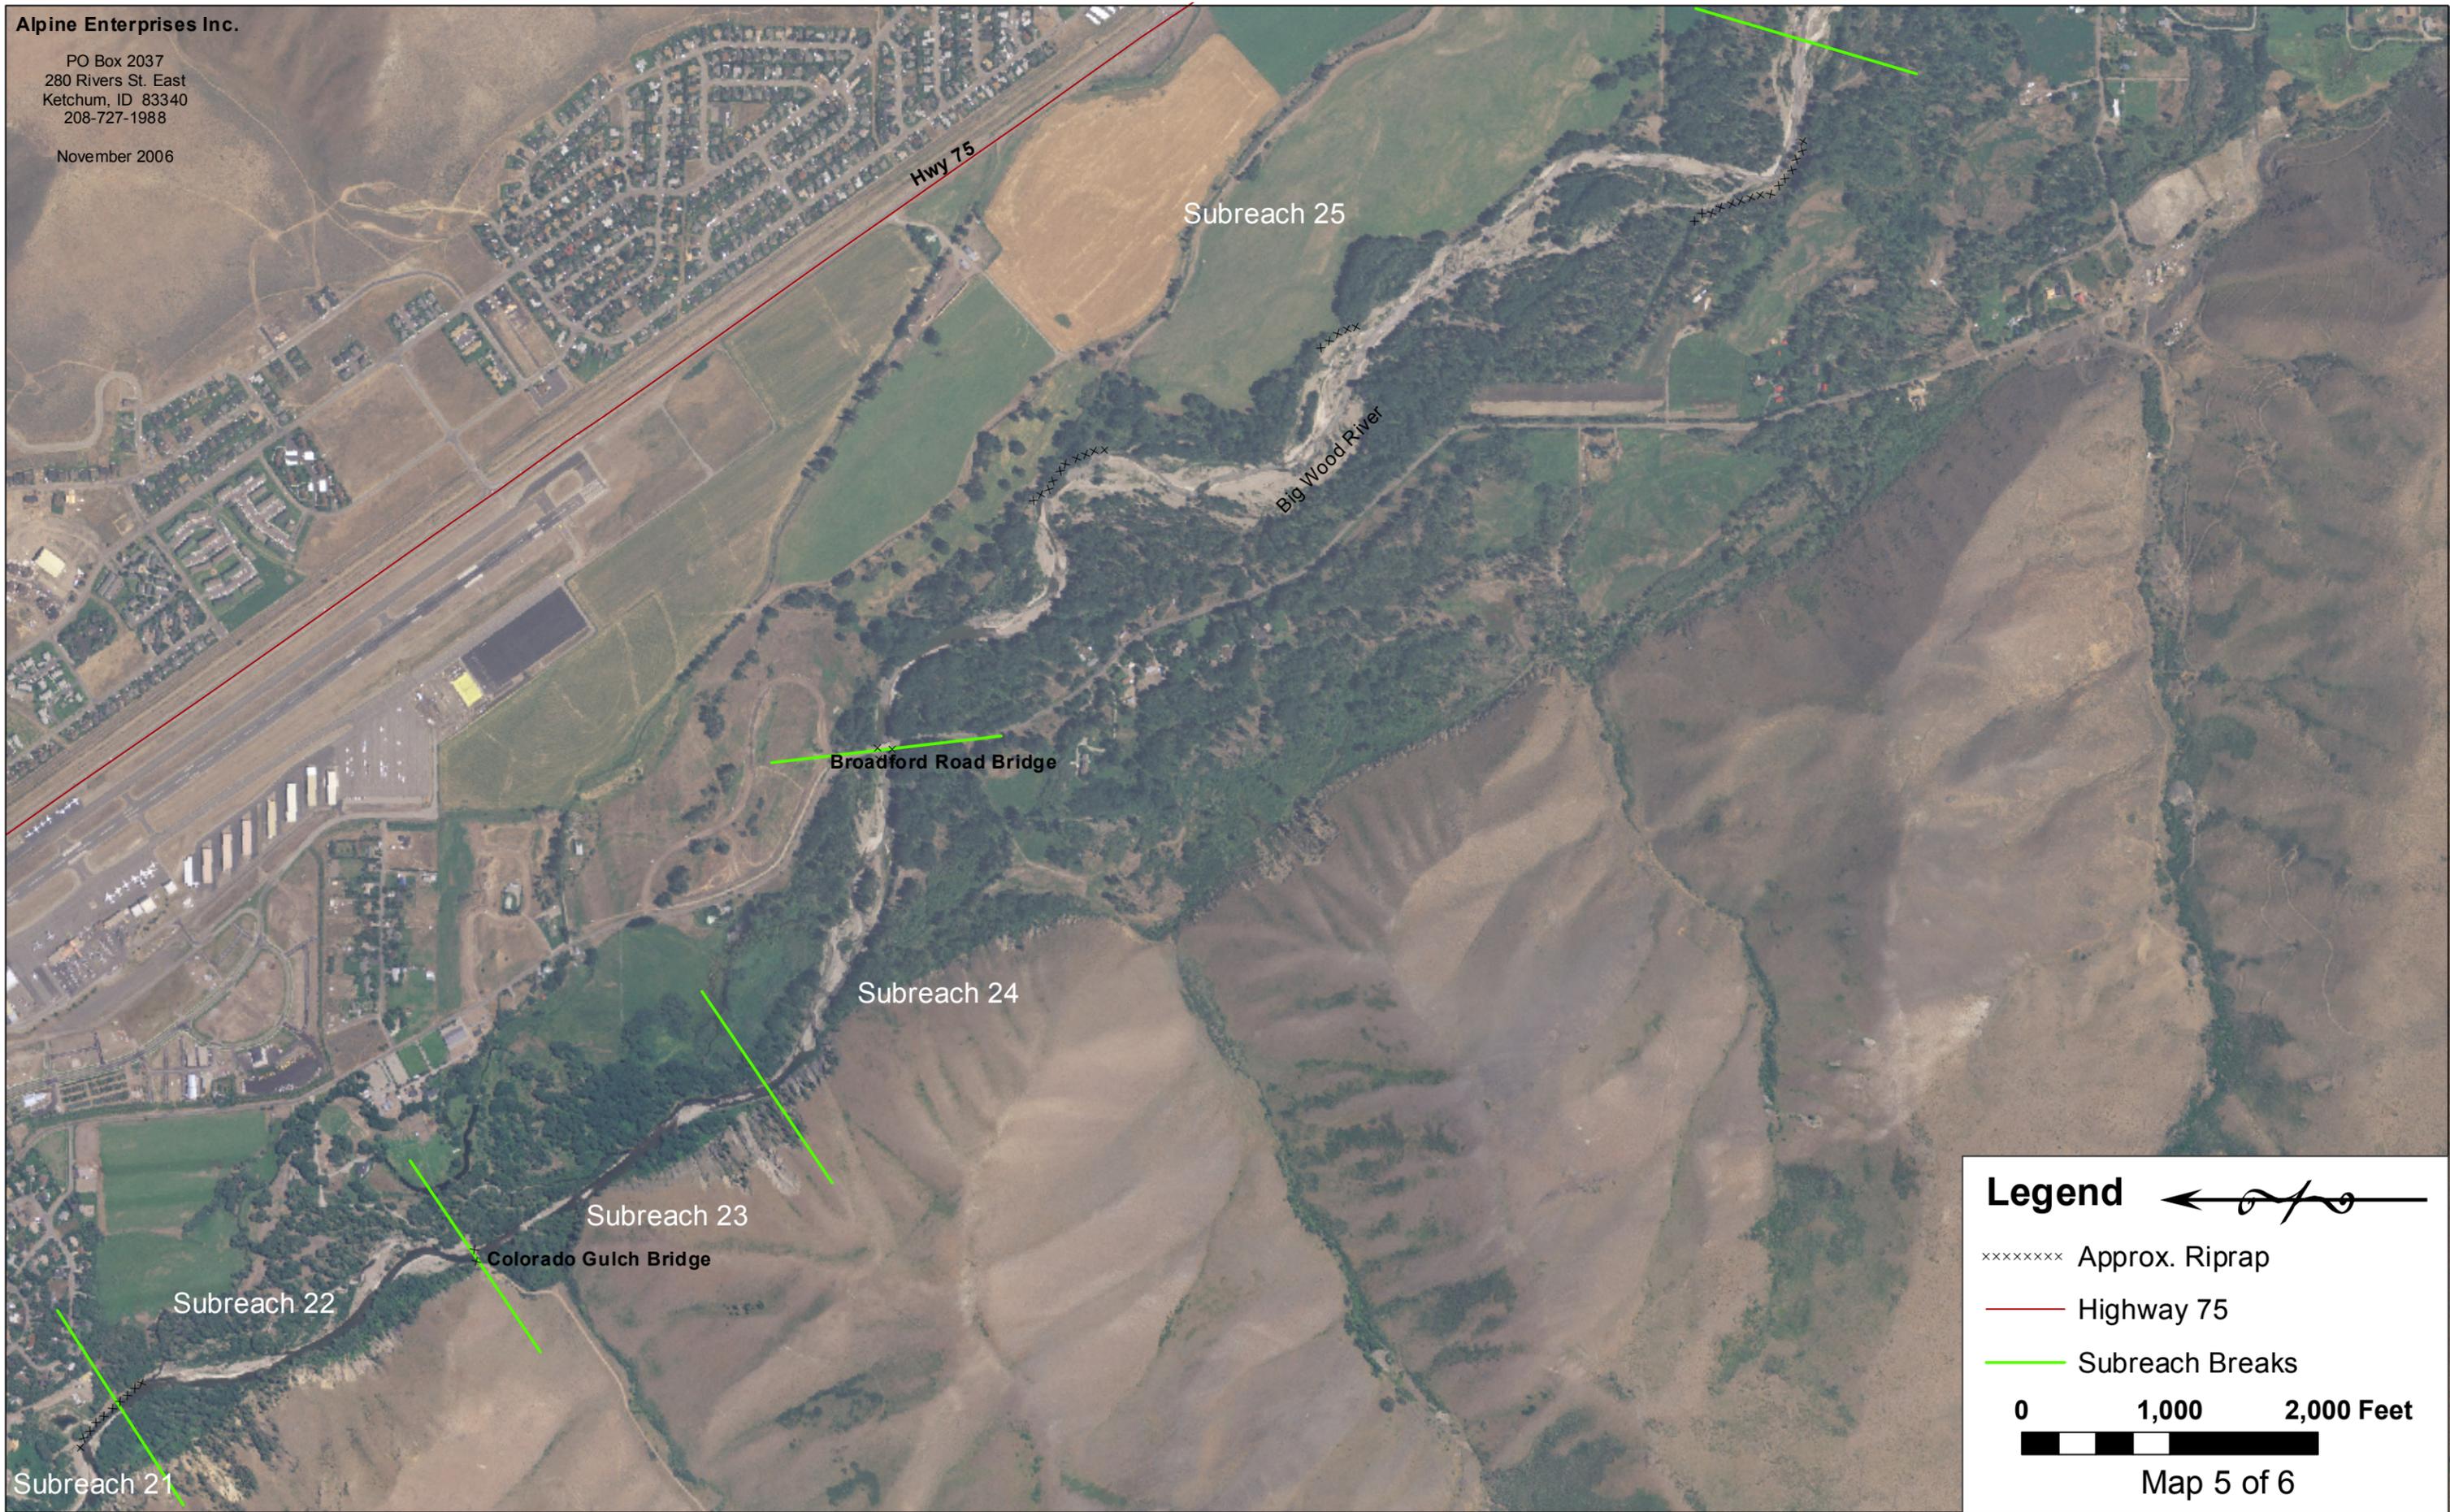
Map 5 of 6

Figure 5 (Sheet 5 of 6). Results of the preliminary bank hardening survey for the Big Wood River within the study reach.

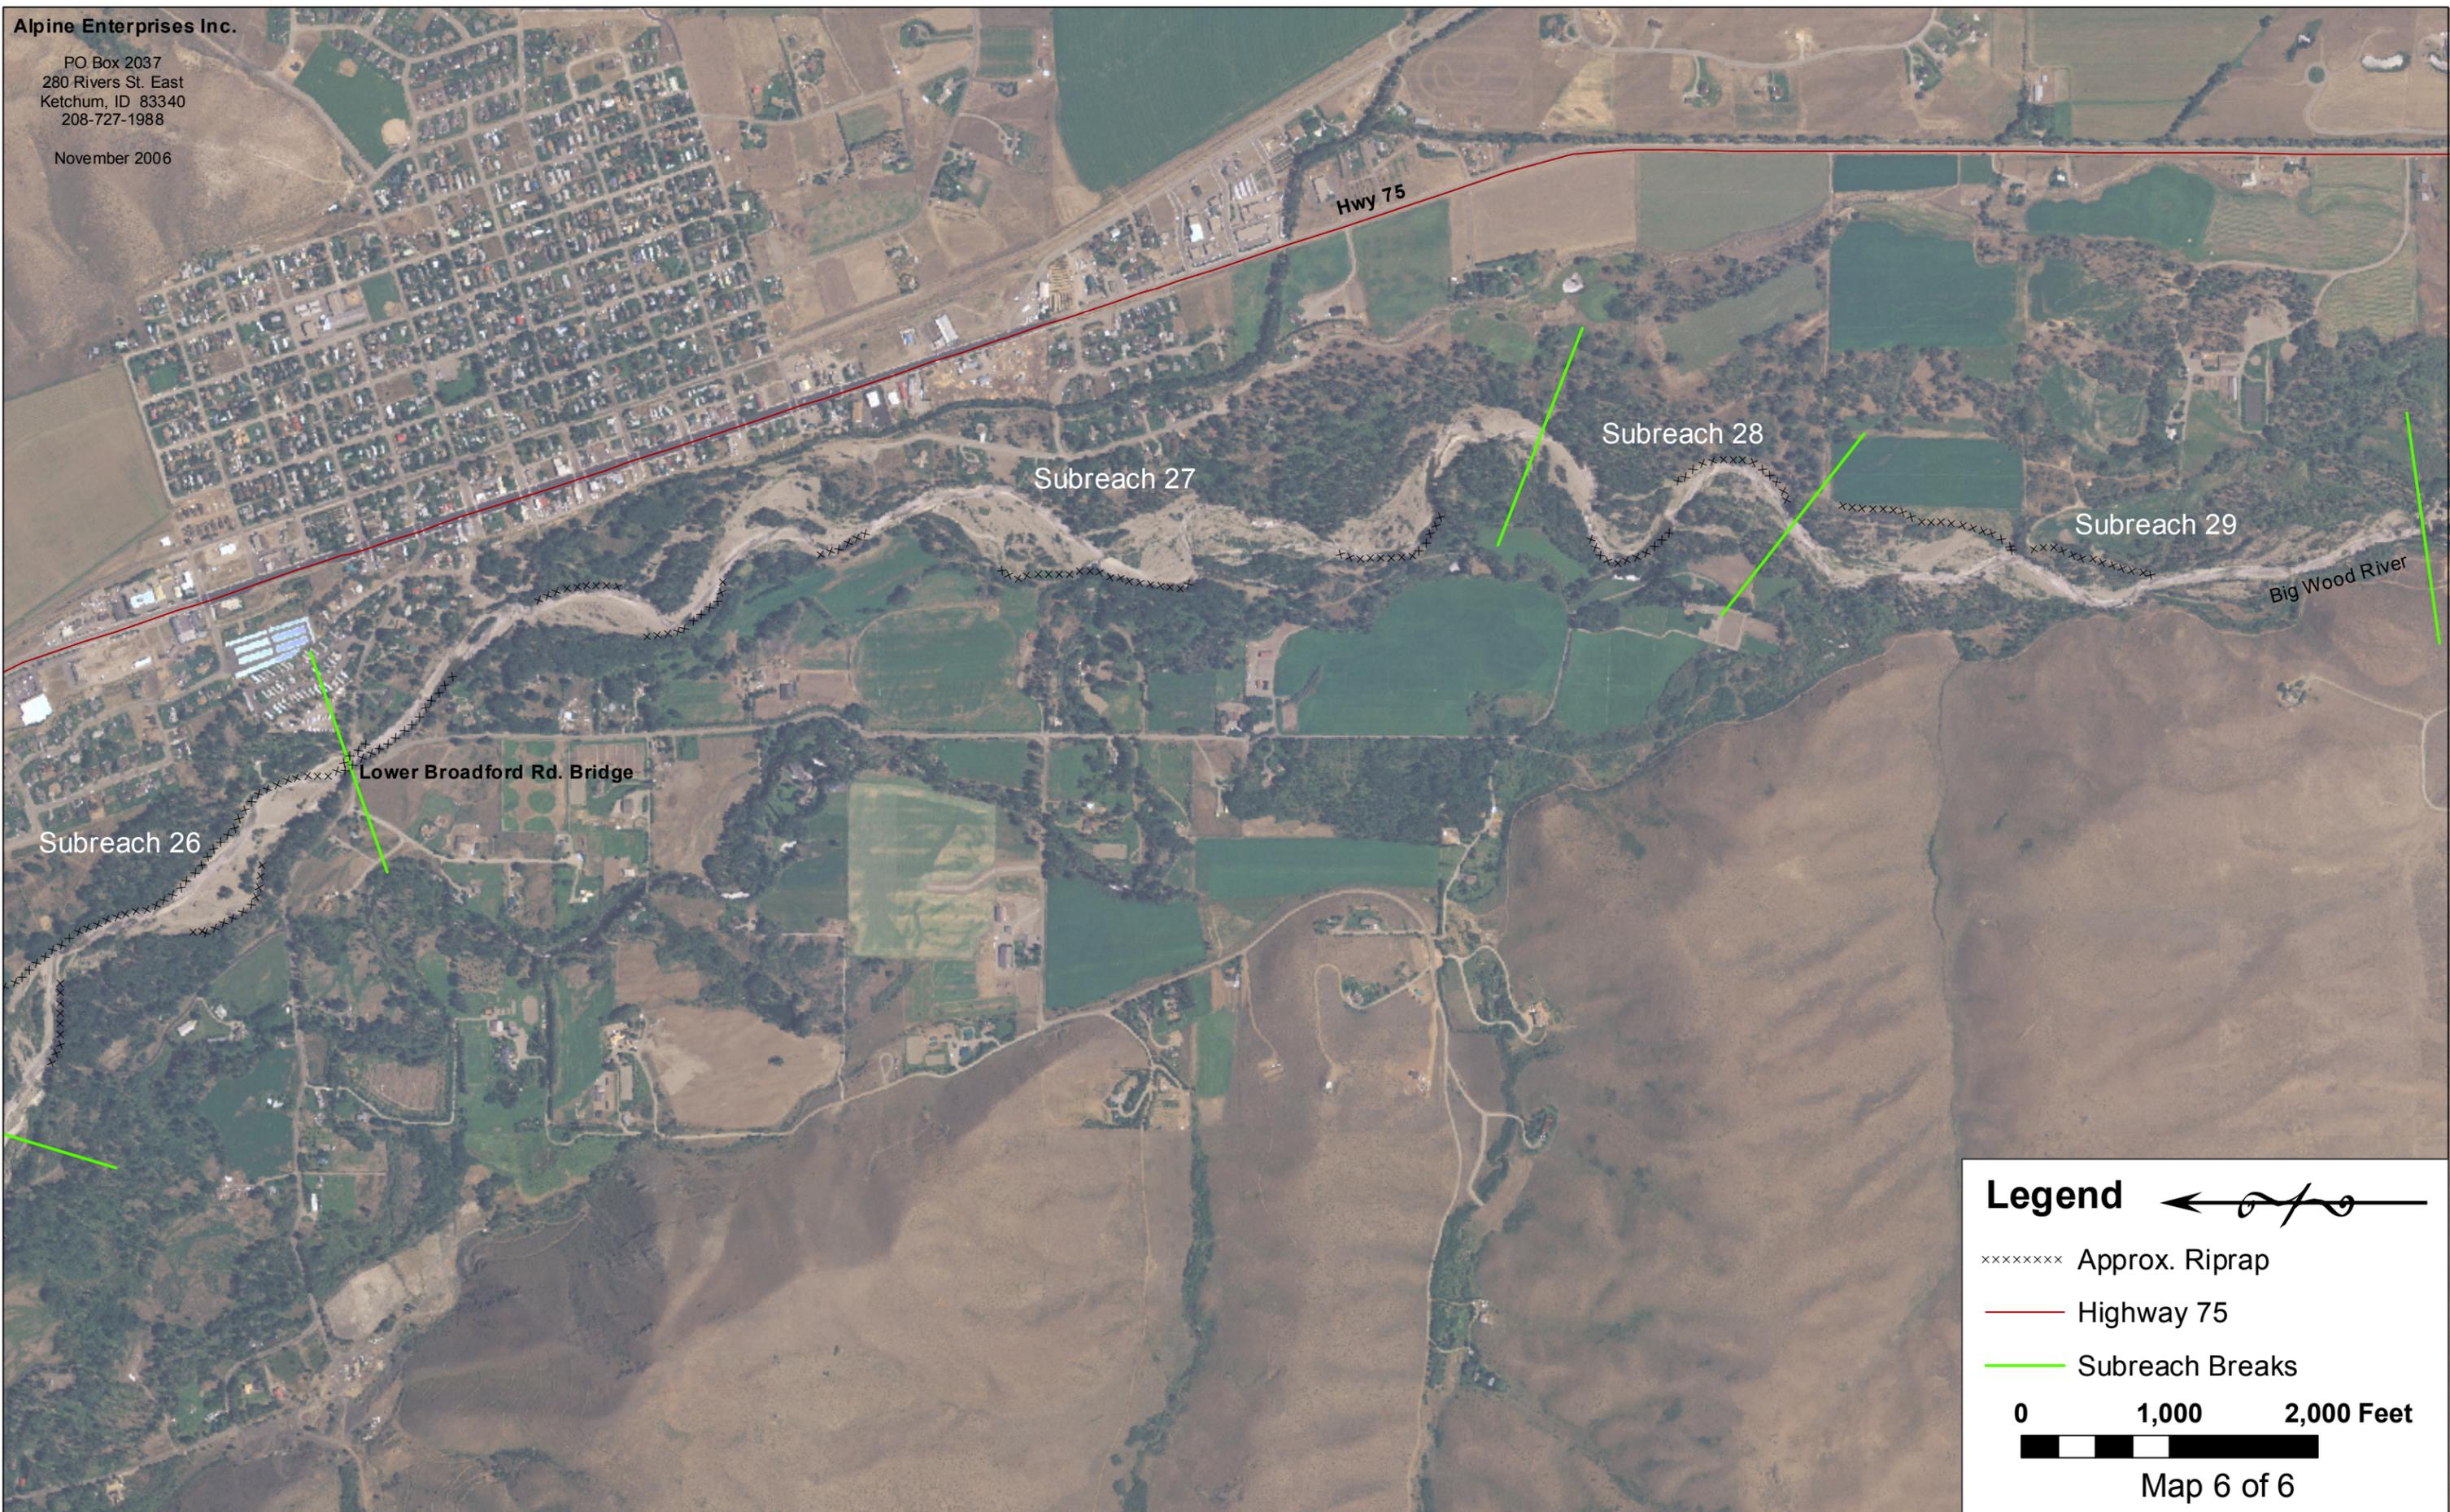
Figure 5 (Sheet 6 of 6). Results of the preliminary bank hardening survey for the Big Wood River within the study reach.

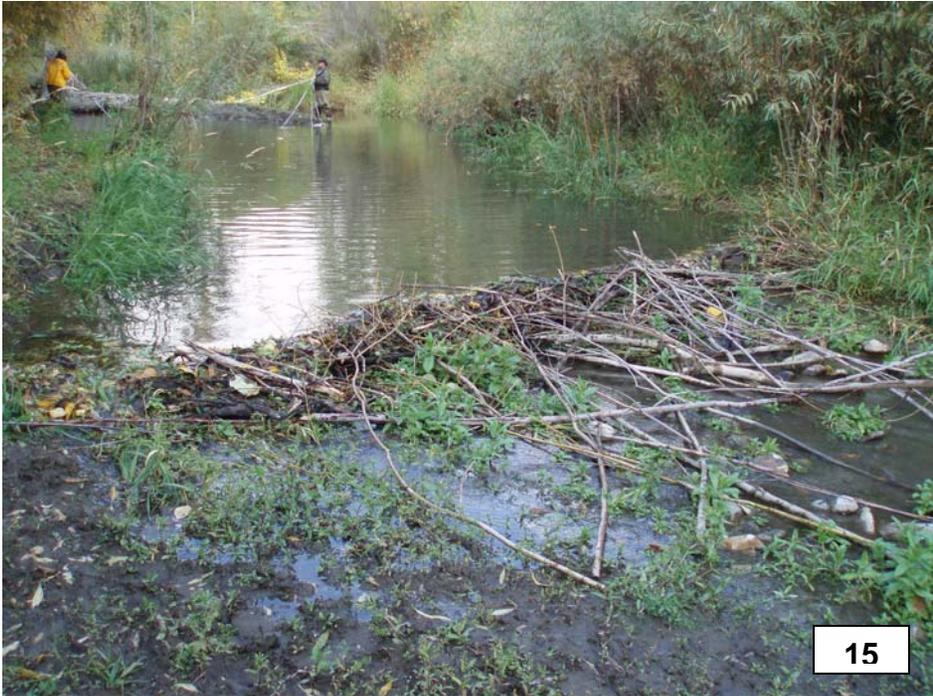
15	Beaver dam, beaver pond, and LWD on side channel of sub-reach 27.
16	Large log jam forcing pool and secondary channel formation in braided section of study reach.
17	Meander jam located downstream of St. Luke's Hospital. This log jam has the potential to be stable for many years and has forced the formation of deep pools and stabilized in-channel storage of sediment in adjoining gravel bar (photos 18 and 19). The meander jam provides gravel bar with protection from erosion while creating and maintaining excellent aquatic habitat. Over time, the stabilized gravel bar may become a vegetated floodplain island as it continues to store additional sediment and revegetate itself.
18	Looking at the upstream end of the meander jam shown in photo 17. The pools located on the right side of the photo are over 6 feet deep with cover provide by the log jam.
19	Looking at the downstream side of the meander jam shown in photo 17. Two key pieces initiated the formation of this log jam; the mean basal diameter of the key pieces is three feet and the mean root wad diameter is 10 feet.
