BIG WOOD RIVER

BIG WOOD RIVER ATLAS

Cardno and Ecosystem Sciences, 2020. Big Wood River Atlas. Prepared for Blaine County, Idaho.

2 River Setting and Process

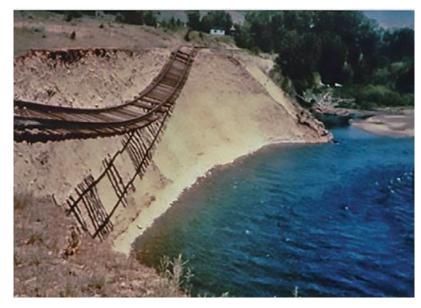
Boxcar Bend, Big Wood River. Courtesy of Wood River Land Trust.

never used. The next major left hand meander upstream is called Boxcar Bend and Union Pacific and maybe Oregon Short Line Railroad have fought continuously to protect the tracks, which were finally undermined by the river in about 1983 even though six or more railroad box cars were placed in the river for protection.

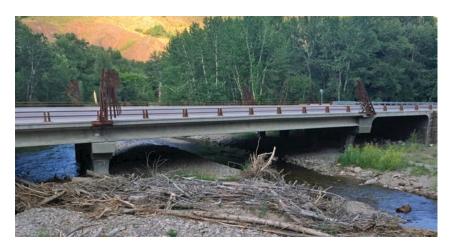
Woody Debris accumulation at Highway 75 bridge pier.

Debris accumulation, typically in the form of woody debris, at channel obstructions is a common occurrence along the Big Wood River during major flood events (Photo Right). Whether upstream of a bridge pier, diversion gate, or mid-channel gravel bar, these debris jams create local effects by inducing bed or bank scour and can also exacerbate local flooding by raising water surface elevations upstream of obstructions. As restoration efforts employ the use of woody debris, this flood impact potential needs to be evaluated by designers.

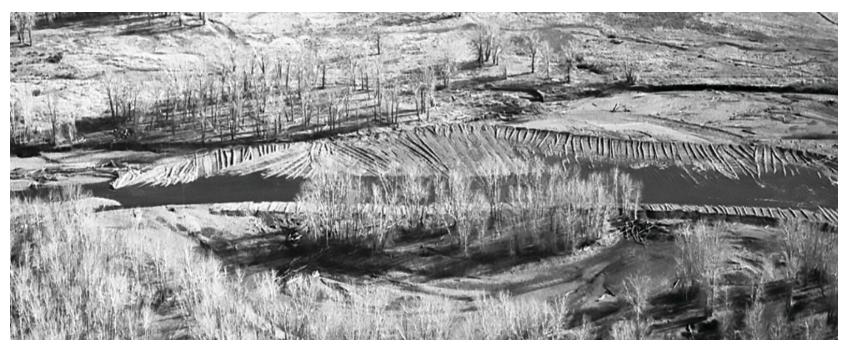
Photos on this page: Big Wood River, oblique aerial images from 1965. Bulldozing and grading of the river channel and streambanks.

The high sediment loads in the Big Wood River were apparently considered a nuisance to residents in the early 1960's, as these photos of gravel removal from 1965 demonstrate. Photos indicate dozer tracks where gravel was dredged from the channel and pushes up onto banks. This was done both in the lower portions of the valley (first photo) and upper reaches (second photo), presumably to address flooding or channel migration concerns. 1965 also correlates with the initiation of levee building in the valley by the US Army Corps of Engineers (Koonce, 2020), so perhaps the two activities are associated.

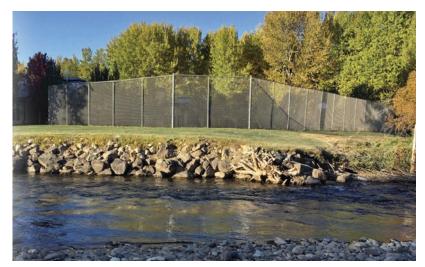
Riprap banks and cleared riparian zone, Big Wood River.

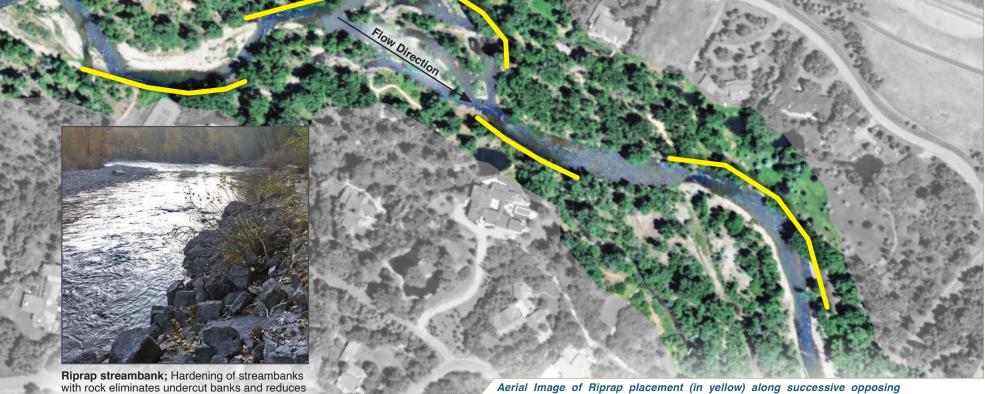
Aerial Image of Riprap placement (in yellow) along successive opposing downstream banks, Big Wood River. Riprap placement can often lead to a cascading effect as downstream erosion worsens as a result of upstream projects.

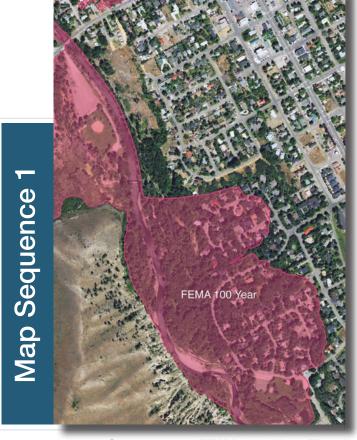
Sequence 1: FEMA 100-Year Flood Boundary

Step 1- Overlay the FEMA 100-year flood boundary. The current, regulatory Special Flood Hazard Area (SFHA) based on modeling of the Base Flood Elevation (BFE) was acquired from FEMA. Though the analysis and mapping completed to produce these boundaries by FEMA is outdated, this area is the sole regulatory mandated zone requiring federal flood insurance and typically represents the only means for a property owner to evaluate a property's risk of flooding. The FEMA boundary is based on hydraulic modeling and flood mapping utilizing bathymetric and topographic data collected in 1970/71, 1993, and 2007, and statistically determined peak flow estimates last updated in 1998. FEMA's countywide flood analysis currently is in the process of updates. FEMA's estimate of the SFHA boundary is based on hydraulic modeling predictions of flood extents during a 6.680 cfs event, which was their estimate of a 100-year flood (1% annual exceedance) at Hailey, at the time of analysis*

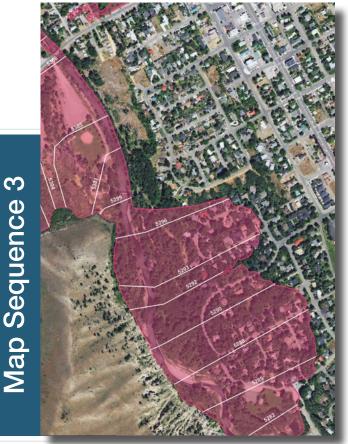
Sequence 3: FEMA 100-Year Flood Boundary and Base Flood Elevation (BFE)

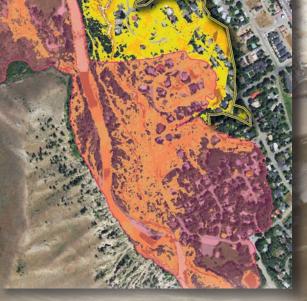
Sequence 4b: BFE / REM comparison with FEMA 100-Year Flood Boundary

Steps 3 and 4- Develop a Relative Elevation Map to Identify Areas Lower than the BFE. Using the FEMA water surface elevation contours for the BFE, we developed a flood surface. Using this elevation surface overlain atop the 2017 LiDAR topography, areas below the BFE were identified. These low lying areas were often not captured or included in the FEMA Zone SFHA since the resolution of their floodplain survey was very coarse and failed to pick up areas in between survey transects. These zones then represent areas of potential flooding, especially those areas contiguous to known or modeled flood zones.

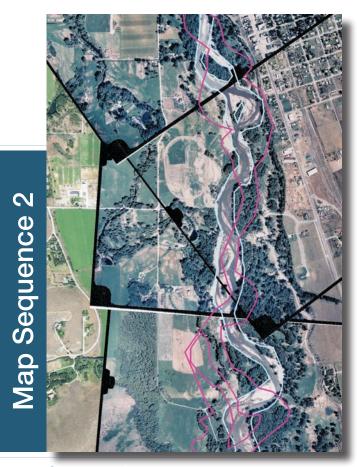
Sequence 2: 1986 Aerial Photo with 1943 channel boundary (pink) and 1986 channel boundary (blue)

This step considers the potential of the river to re-occupy areas between the current channel location and areas of prior channel occupation. River channels tend to migrate within their former HCMZ unless cut off or confined from doing so. The area in between the 2017 channel and the edge of the HCMZ is considered to have Moderate Erosion Potential unless a High Potential Area is identified. erosion trends intersected with topographically favorable (i.e. low lying) conditions, areas of high erosion potential were identified and delineated. Where these zones are identified within the HCMZ, the remaining area to the edge of the HCMZ is delineated as moderate; where these zones extend beyond the HCMZ, a narrow buffer of moderate erosion potential is applied beyond the HCMZ.

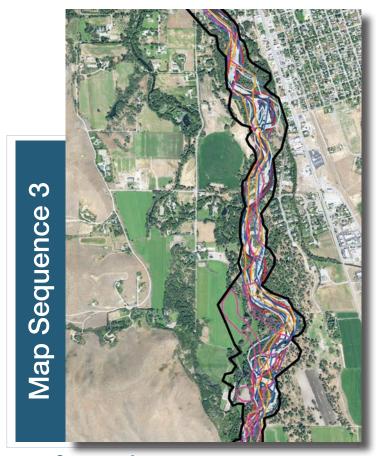
Sequence 3: Delineation of the Historical Channel Migration Zone (in black), established using the outer limits of all channel boundaries.

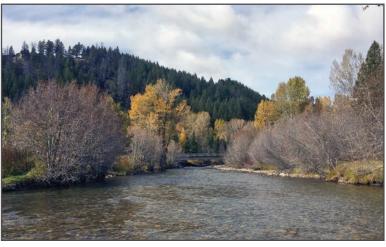
Reach 1 - Photo Point 1 Looking upstream towards Highway 75

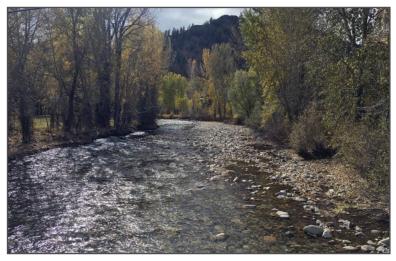
Reach 1 - Photo Point 4 - Looking downstream

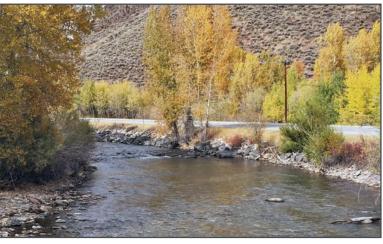
Reach 3 - Photo Point 1 Looking upstream in Reach 3

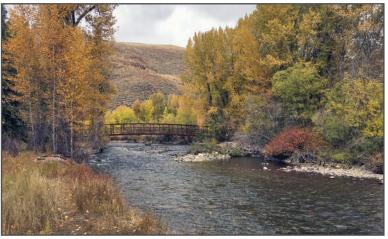
Reach 3 - Photo Point 2 Pedestrian bridge crossing over Big Wood River

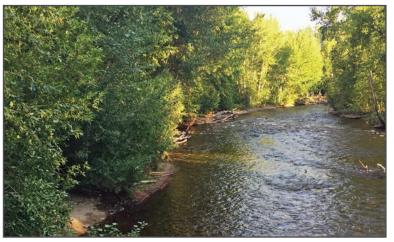
Reach 5 - Photo Point 1 Looking downstream from Warm Springs Rd bridge

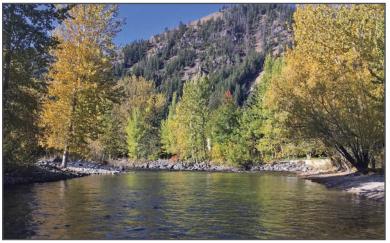
Reach 5 - Photo Point 2 Looking downstream, riprap wall in background

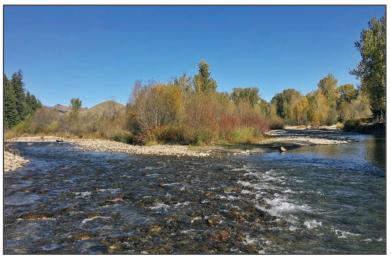
Reach 6 - Photo Point 1 Warm Springs Creek confluence

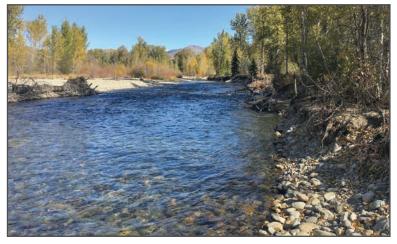
Reach 6 - Photo Point 2 - Looking downstream

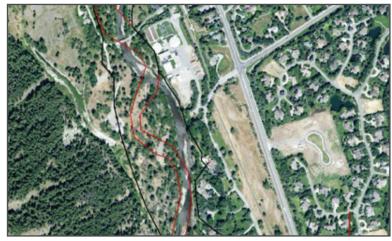
Reach 7 - Photo Point 2

An excellent opportunity exists across from the WWTP to reconnect the channel to its historic 1943 location (in red). Consideration must be given to the maintenance of WWTP intake or discharge locations

An excellent opportunity exists across from the WWTP to reconnect the channel to its historic 1943 location (see aerial image above). Given the impacts of high sediment deposition on channel dynamics farther downstream near the hospital bridge, opportunities to restore natural channel processes upstream of the bridge are recommended.

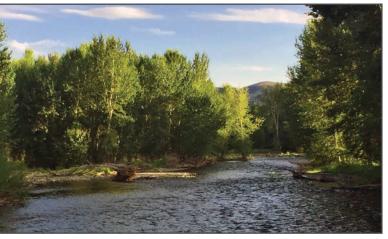
Reach 9 - Photo Point 1 Looking downstream from Gimlet Rd bridge towards split flow channel.

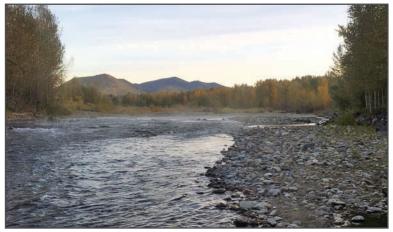
Reach 13 - Photo Point 1

2017 floods led to major channel changes; use of log jams or flood fencing could help store sediment and reduce impacts on channel migration and bank loss downstream.

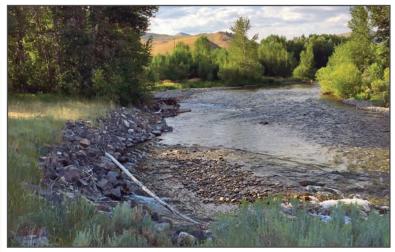
Reach 13 - Photo Point 2 Looking upstream from Deer Creek Bridge.

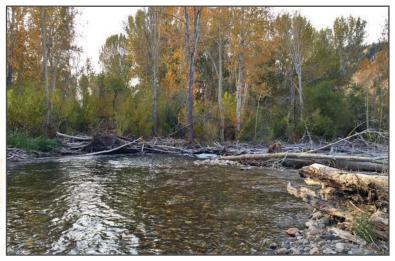
Reach 14 - Photo Point 1 Wood recruitment into Reach 14 during 2017 flood.

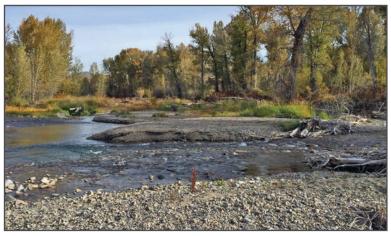
Reach 14 - Photo Point 2 Rapid channel change during 2017 flood leaves complex and varied channel conditions.

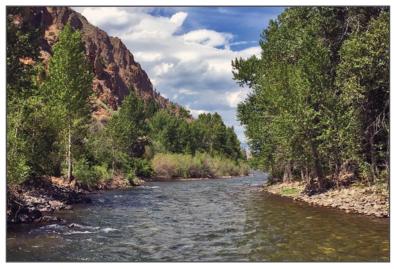
Reach 15 - Photo Point 1 Looking upstream from Croy Creek bridge.

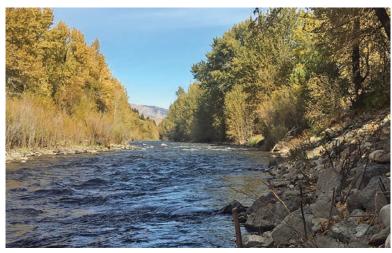
Reach 15 - Photo Point 2 Looking upstream in Reach 15

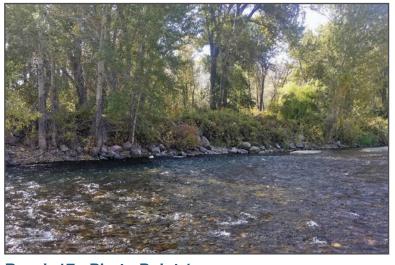
Reach 17 - Photo Point 1 Right bank levee and Broadford Road disconnect the river from historic channels and floodplain.

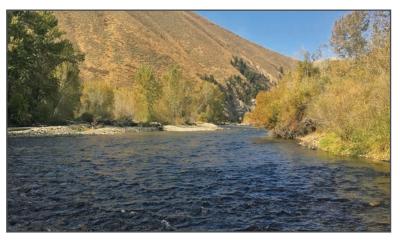
Reach 17 - Photo Point 2 Looking upstream from Star Bridge crossing the river.

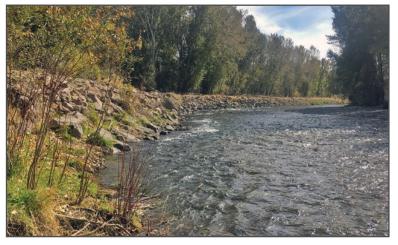
Reach 18 - Photo Point 1 Broadford levee is an imposing barrier to natural channel movement into the east floodplain of the river

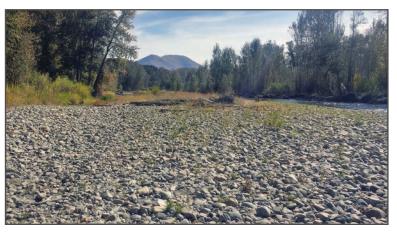
Reach 18 - Photo Point 2

Channel expansion as a response to confinement upstream led to erosion and migration during the 2017 floods

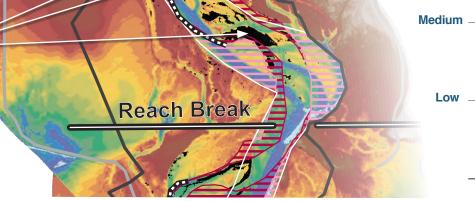
REACH MAP - HAWS

Height Above Water Surface (HAWS), Erosion Hazards, HCMZ

There may be advantageous locations in this reach to remove rock riprap in key locations that would not impact infrastructure. HAWS mapping indicates the presence of many near channel and off channel features that are topographically desirable for reconnection. This reach contains similar flood fencing and LWD jam potential as the upstream reach.

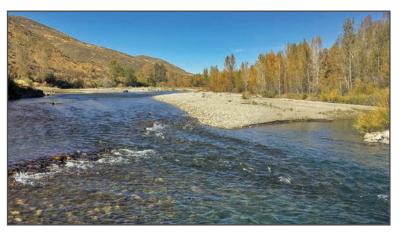
Reach 21 - Photo Point 1 Looking upstream of Glendale Diversion

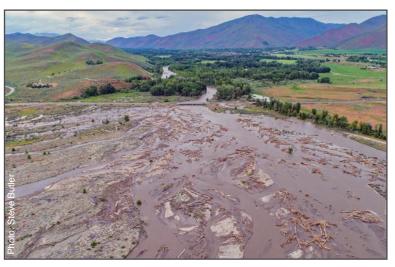
Reach 21 - Photo Point 3 Looking upstream towards Glendale Road

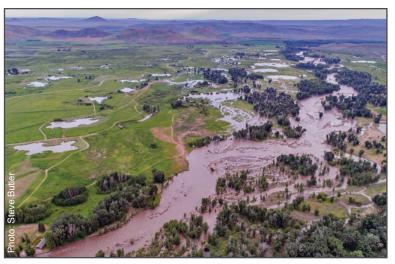
Reach 22 - Photo Point 1 Looking downstream towards HWY 20

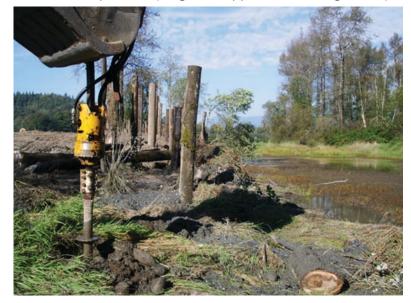
FLOOD FENCE PLAN VIEW

Floodplain Roughening

- •Increase hydraulic roughness on floodplains
- Stabilize bars
- ·Increase floodplain soil stability/reduce erosion
- •Promote natural vegetation/seed recruitment through sediment deposition (long term approach to revegetation)

Flood Fence; Courtesy of Cardno.

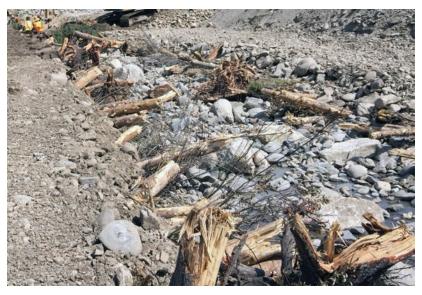
Roughness Trees/Small Woody Debris

- Roughness provided by woody material provides short term bank stability through slowing of flow velocities
- Incorporation of live vegetation re-establishes long term bank strength through root structure

Installed Brush Bank Treatment; Courtesy of Cardno.

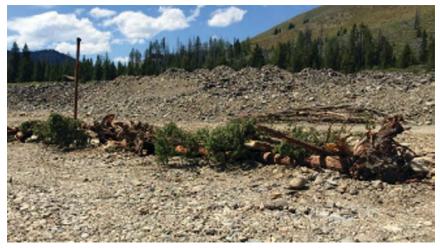
- Provide scour/erosion protection
- ·Increase hydraulic roughness and reduce velocities and shear stresses along channel margins
- •Incorporation of live vegetation re-establishes long term bank strength through root structure

Channel Margin Jams; Courtesy of Cardno.

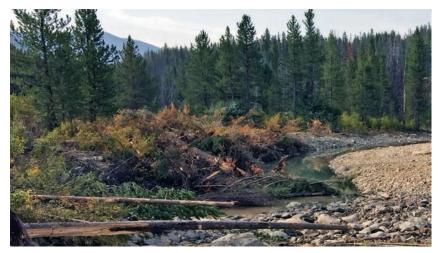
Meander Bend Jams; Courtesy of Cardno.

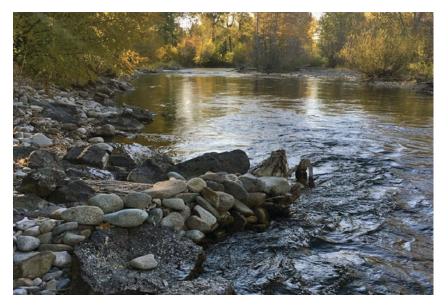
Log rootwad and boulder revetment in Big Wood River; Courtesy of Cardno.

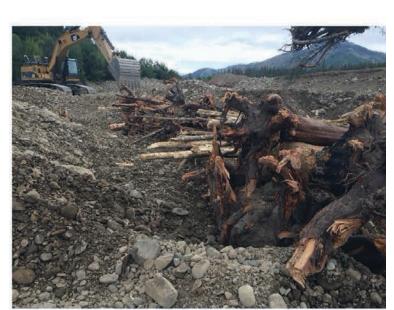
• Provides bank stability by increasing hydraulic roughness along outside of bends and reducing channel velocities and shears •Directs concentrated flows away from the bank

EXAMPLE: INSTALLED LOG TOE long outside of bend in newly consoliding bank stabilization. Looking (Photo courtesy of S. Rodriguez) d bank (devoid of

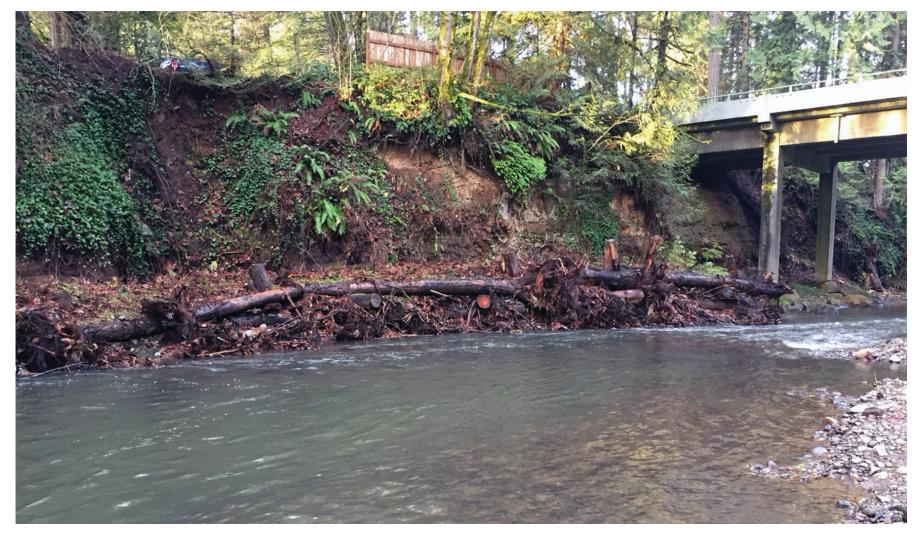
Log Revetment protecting eroding bank and downstream bridge pier ; Courtesy of Cardno.

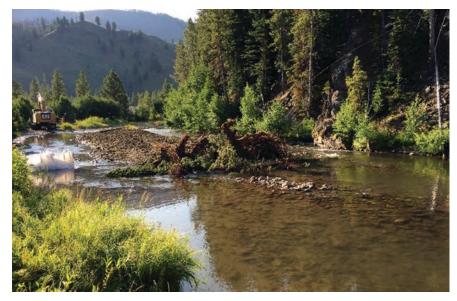
- ·Protect/stabilize downstream riparian islands and gravel bars
- ·Recruit LWD debris upstream of vulnerable reach/infrastructure (i.e. bridges)
- Redirect flows into off-channel areas

Detail of mid-channel bar-apex jam. Photo of installed mid-channel bar apex after high flows with recruited mobilized debris in Yankee Fork River, Custer County, Idaho; Courtesy of Cardno.
